PORT AND OCEAN ENGINEERING UNDER ARCTIC CONDITIONS
TECHNICAL UNIVERSITY OF NORWAY

SUBAQUEOUS SLOPE FAILURES IN
NORWEGIAN FJORDS

Laurits Bjerrum, Dr.sc. Norwegian Geotechnical
Institute Oslo, Norway

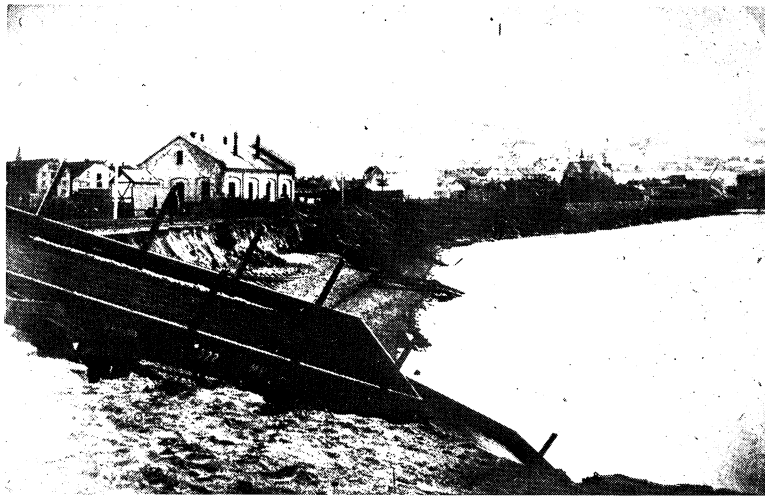
The largest of the two slides occurred on April 23, 1888. From the testimony of the witnesses (Skaven Haug, 1955) it has been established that the events started by the appearance of a 5 to 7 m high flood wave formed in the fjord about halfway between the island Munkholmen and Ilsvika, see Fig. 3. The wave propagated towards the shore line and first struck land at Ilsvika. Some minutes later it reached the jetty confining the area reclaimed several years earlier for the railway station at Brattøra. At the instant the wave reached Brattøra, or perhaps when it receded, the jetty and the fill behind it slid out with three railway tracks over a length of about 170 m. One man lost his life.

The jetty and the fill rested on the original sand surface sloping at 8-15 degrees towards the fjord. After the slide the depth of water next to the failed area had increased by nearly 10 m and as far out as soundings were made the increase in depth was of the same order of magnitude. The width of the slide next to Brattøra was about 600 m.

PHOTO 1 The slide in Trondheim 1888
Seen from north

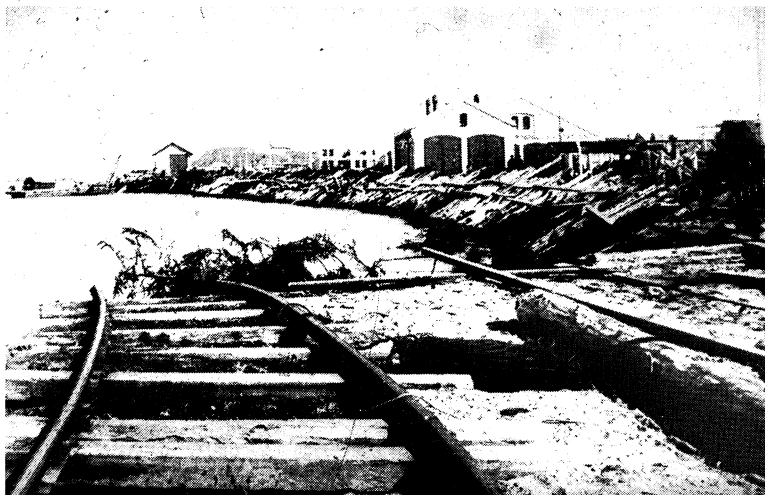
PHOTO 2 The slide in Trondheim 1888
Seen from south

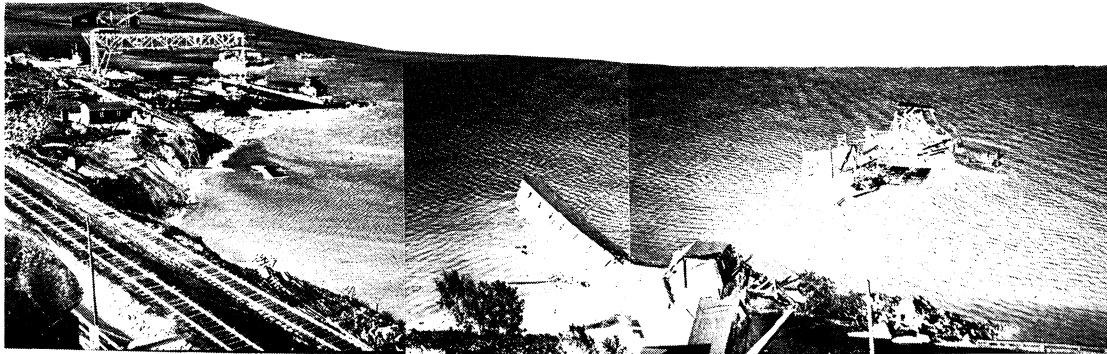
The slide occurred in the night and no details of the events are available. The visible result was the disappearance of the recently reclaimed area over a length of 150 m and with an average width corresponding to three railway tracks, see Fig. 3. From soundings carried out after the slide it was established that a very large area of the bottom of the fjord outside Ilsvika had been involved in the slide. The dimensions of this slide were of the same order of magnitude as those of the slide which occurred in 1888, in width being about 600 m and this slide also extended towards the middle of the fjord as far as soundings were made.

The soil conditions in the areas which were involved in the slide are known to be characterized by thick deposits of fine sand and silt. It is, however, notorious that below the recently placed fill outside Ilsvika some soft clay layers were present locally and it is though possible that the failure of the reclaimed railway area may be the result of an overloading of the clay with the fill which was up to 12 m thick.

The slide in Trondheim in 1950 may similarly have been started by an initial slide in the slope, some distance from the shore line. It is, however, most likely that the initial slide was the result of an

overloading of the clay beneath the fill and that the subsequent much larger slide outside Ilsvika was the result of erosion caused by the slide masses from the initial slide, followed by a series of retrogressively developing slides.

PHOTO 3 The slide in Trondheim 1950

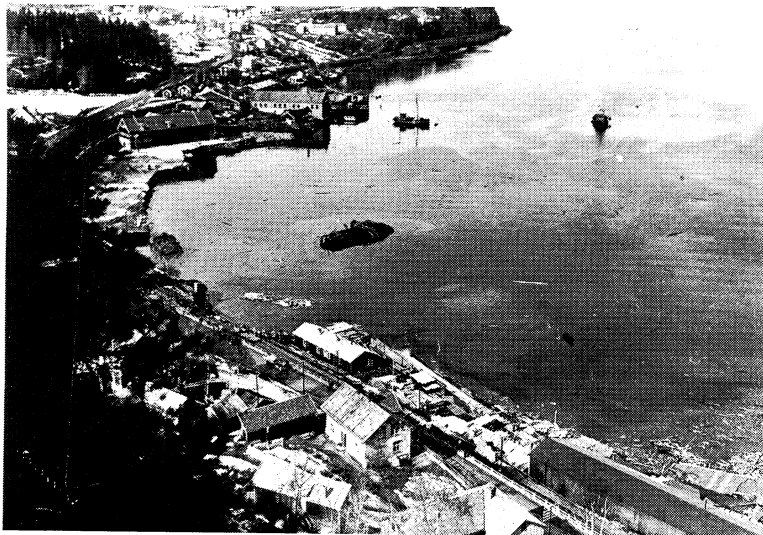
The slide took place at 7:45 p.m. on April 14, 1942. This was 40 minutes after spring low water tide. The slide started by the disappearance of the area recently filled-in. It propagated quickly in a southern direction, see Fig. 4, and caused first the failure of another recently reclaimed area next to the Halstad river and then the failure of the outermost part of the deep water harbour recently completed by the Norwegian State Railways. Finally, the older part of the deep water harbour slid out.

Measured along the shore line the slide has a length of 450 m and on the average the slide came to a halt at a distance of about 40 m from the water front. Two men lost their lives.

The slide in Hommelvik was beyond any doubt initiated by an overloading of the fine grained foundation soil beneath the fill and the propagation was the combined effect of erosion by the slide debris and a retrogressively developing slide activity.

PHOTO 4 The slide in Hommelvika 1942

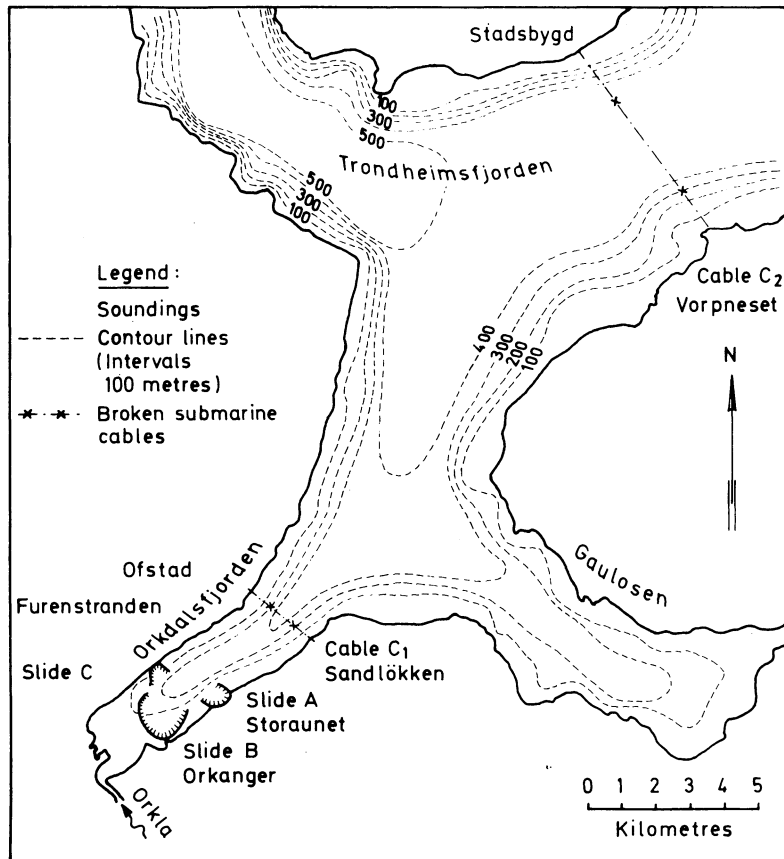
Fig. 2. Slide in Orkdalsfjord,
May 2, 1930 (Terzaghi 1956)

The slide occurred in the early morning at an exceptionally low tide and was observed at the following points (Fig. 2):

(1) At Storaunet about 1000 to 1500 m³ of a minor filling which had been recently placed along the shore disappeared at 7:48 a.m. in a slide (slide A) that stretched 500 m along the edge of the fjord; it was preceded by the formation of a small wave some distance out in the fjord.

(2) A few minutes later a 600 to 700 m long slide at Orkanger, approximately 2 km away, destroyed some piers and harbour works, slide B.

(3) On the opposite side of the fjord a slide took place at Furenstranden at 7:55 to 8:00 a.m., slide C.

(4) Three kilometers from Storaunet the Ofstad-Sandløyken telephone cable crossed the fjord at a water depth of a maximum of 300 to 350 m. At 7:55 a.m. the cable was broken, indicating that the slide had propagated from Storaunet with a speed of about 25 km/hour.

(5) Approximately 18 km further along the fjord, the Vorpeneset-Stadsbygden cable crossed at a water depth of 500 m. Failure of this cable at 9:40 a.m. corresponded to an average speed of propagation of 10 km/hour since the occurrence of the initial slide.

From the observed changes in water depth it has been calculated that about 25 million m³ of soil had been moved by the three first-mentioned slides (Vogt, 1943). Borings carried out near the areas where the two major slides A and B occurred indicate the existence of large deposits of a very loose and soft non plastic silt, having a water

In Orkdalsfjorden the initial slide, slide A in Fig. 2, was the result of loading with an embankment an already highly stressed underwater slope in fine sand and silt. An artesian water pressure in the rock beneath the slope may have contributed to its instability. As the slide masses flowed down the 250 m high and relatively steep slope it cut a deep canyon into the sand. A series of retrogressively developing slides were initiated by slides from the walls of this canyon and these propagated into the estuary in the inner part of the fjord and caused first the subsidence shown as slide B in Fig. 2 and then the failure at slide C. On its way out into the fjord the liquified masses of sand probably initiated a new series of retrogressively developing slides by erosion of the toe of the slopes along the fjord. The result was that the flow slide repeatedly received new supplies of liquified sand which kept it moving. The occurrence of such slides were, however, only observed at the two locations where cables crossed the fjord.

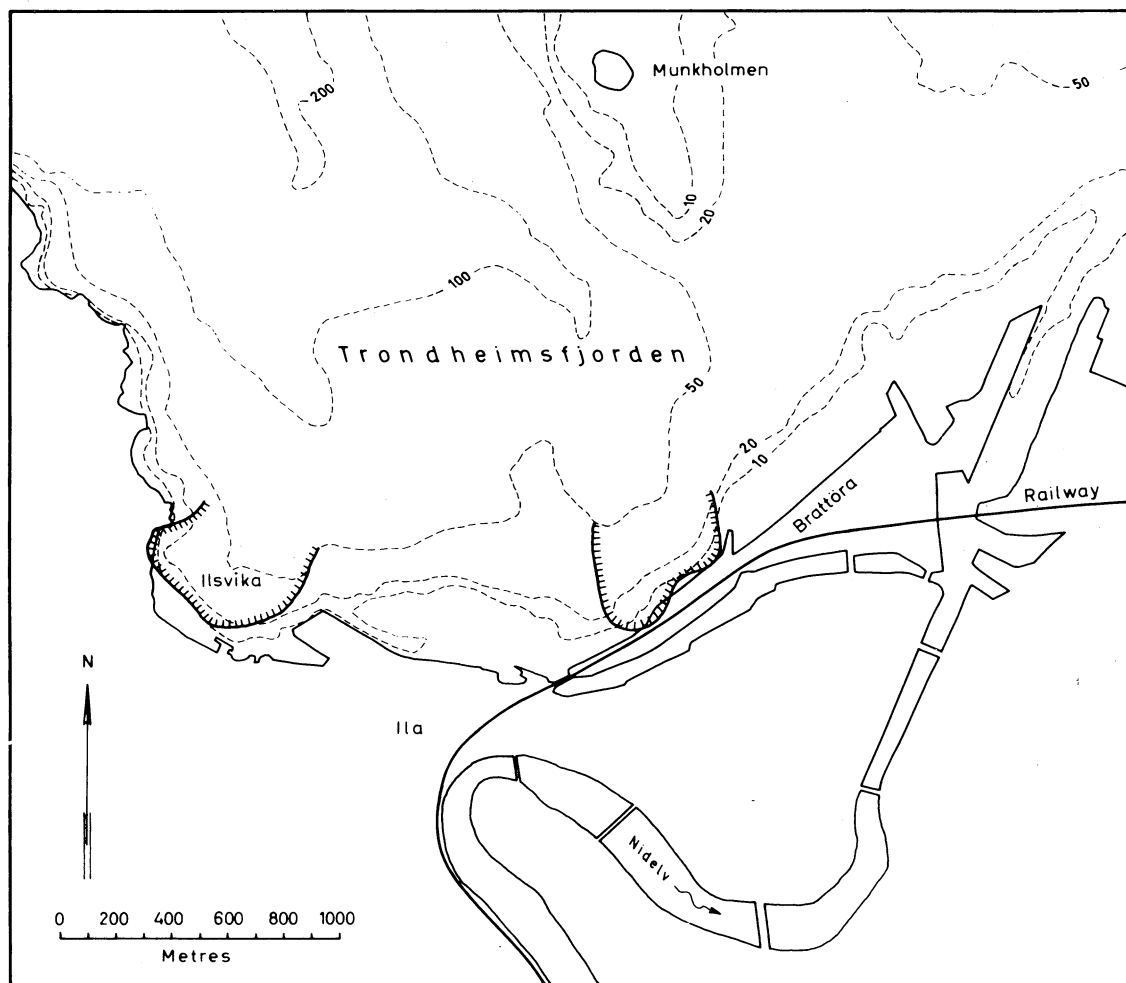
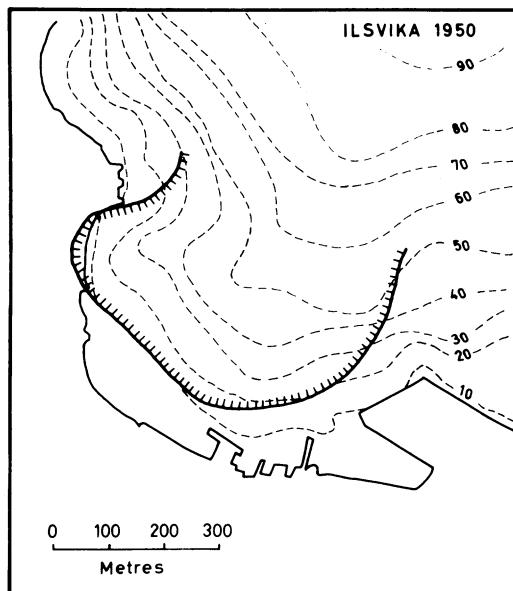
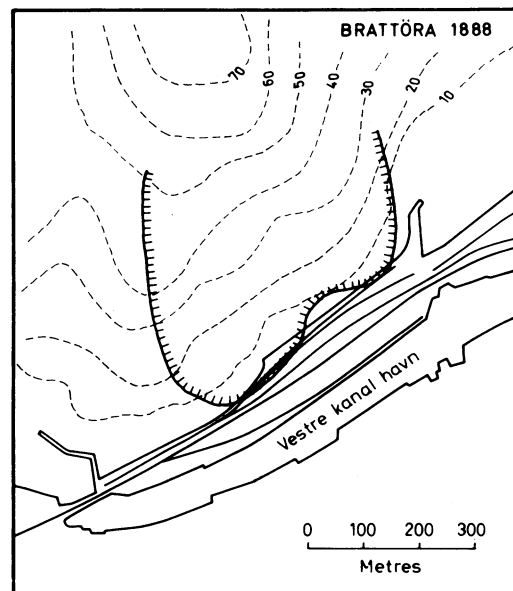
(Skaven Haug 1955)
 Fig. 3. Slides in the harbour of Trondheim
 on April 23, 1888 and October 8, 1950

The harbour was originally a river harbour but since the end of last century its character has changed. The river outlet has been regulated, see Fig. 3, and new quays and piers have been built along the shore line by reclaiming areas by filling. During this period of development two large slides have occurred causing failures of harbour structures.

On October 8, 1950, another large slide occurred in the harbour of Trondheim, but this time at Ilsvika, see Fig. 3 (Skaven Haug, 1955). In 1949 the State Railways extended their area by reclaiming a strip of land along the water front at Ilsvika. In 1950 another strip of land further out was constructed by the placing of fill on the natural bottom of the fjord, and by October 8 the construction was almost completed.

The slide in the harbour of Trondheim in 1888 was initiated by an initial slide at great depth of water. No explanation can be given for the occurrence of this slide, but it is known that the slopes in the area were locally rather steep. In addition boats arriving in the harbour frequently dumped their ballast in this area. From the initial slip the slide developed retrogressively into the sand slope and first came to a halt when it reached more dense sand deposits below the filled-in areas at Brattøra. The flow slide following the slide is not known to have caused additional damage.

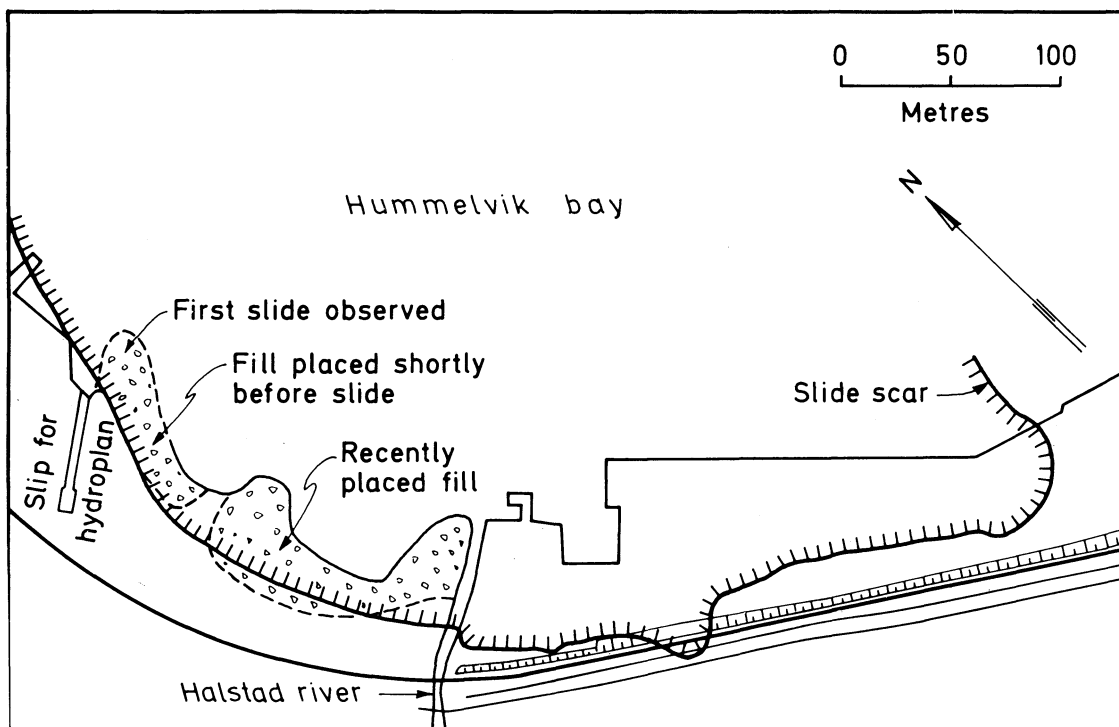
Fig. 4. Slide in Hommelvika, April 14, 1942

In the period up to the slide rock fill was being placed in order to reclaim an area in the harbour of Hommelvika for a military slipway for hydroplanes. Two days before the slide the outermost part of the fill slid out but the filling was resumed and continued until the main slide occurred, see Fig. 4.

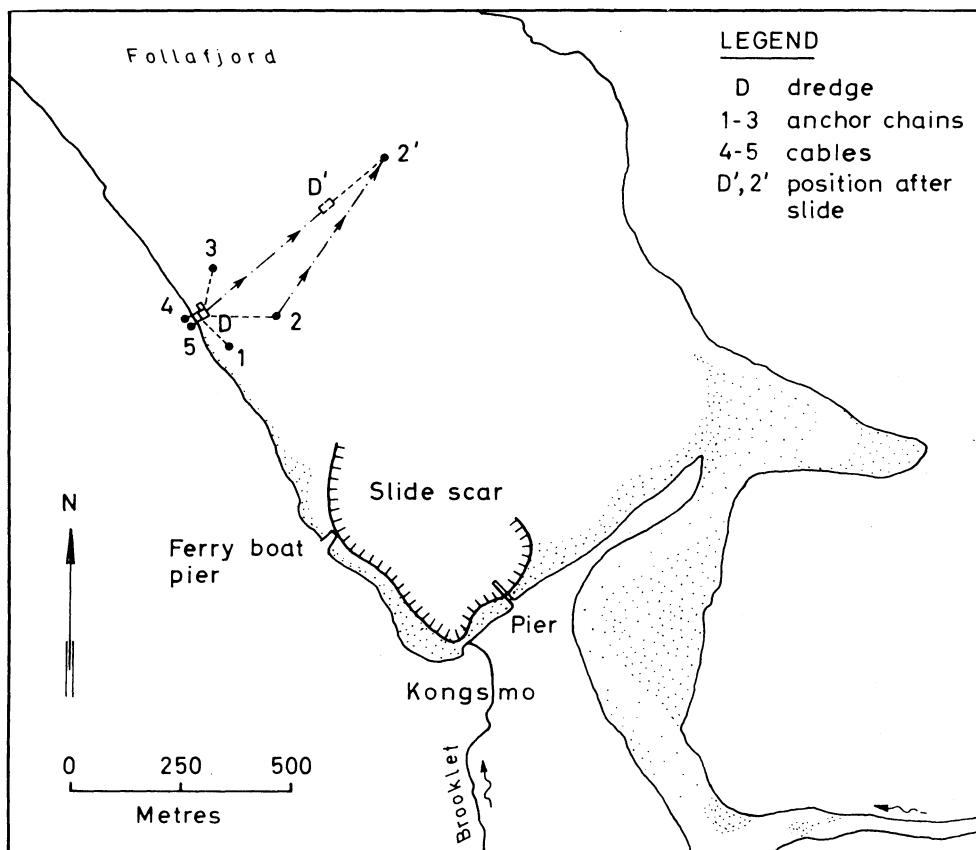
Fig. 5. Slide in Follafjorden, January 9, 1952

The situation before the slide took place is shown on Fig. 5. Follafjorden is a fjord about 600 m wide and 40 km long cut down between steep rock walls. The site of the events, Kongsmo, is a small village located at the extreme end of the fjord where an adjoining river has formed an estuary. From the estuary the bottom of the fjord slopes outward with an inclination of about 5 to 7%. The sediments are fine sand and silt and are known to be loosely deposited.

In the period preceding the slide a local mining company was constructing a small harbour. A dredger, "Yankee", was working at the location of the harbour shown in the upper left corner of Fig. 5. In the evening of January 9 it had been anchored by three 60-100 m long chains, nos. 1, 2 and 3, attached to anchors dropped at the bottom of the fjord, and by two cables, nos. 4 and 5, to the shore. At 8:03 in the evening anchor no. 3 was taken by a slide and broken leading to an outwards movement of the dredger and the failure of

It was later discovered that in the period between the first slide and the displacement of the dredger a tremendous slide had occurred in the interior part of the fjord, where the depth of water had increased by up to 20 m. Through the clear water the slide scar could be followed over a length of a kilometer, see Fig. 5. A consequence of this slide was the failure of two landing piers.

The events occurring in Follafjorden in 1952 were started by an initial slide which took place in a great depth of water and probably near the toe of the slope. This initial slide may very well have been initiated by the dumping of fill from the dredging operations. The initial slide started a series of slides gradually encroaching into the slope to its rear and finally reaching the anchor of the dredger. When the slide masses from this series of slides descended the slope and were forced to change direction at the deepest point of the fjord, very severe erosion occurred. From the scars of this erosion a new series of slides was initiated which gradually involved in the movements the estuary in the interior part of the fjord. It was the flow slide from this very voluminous slide which impinged upon the anchors of the dredger and for the second time moved it out into mid-fjord.

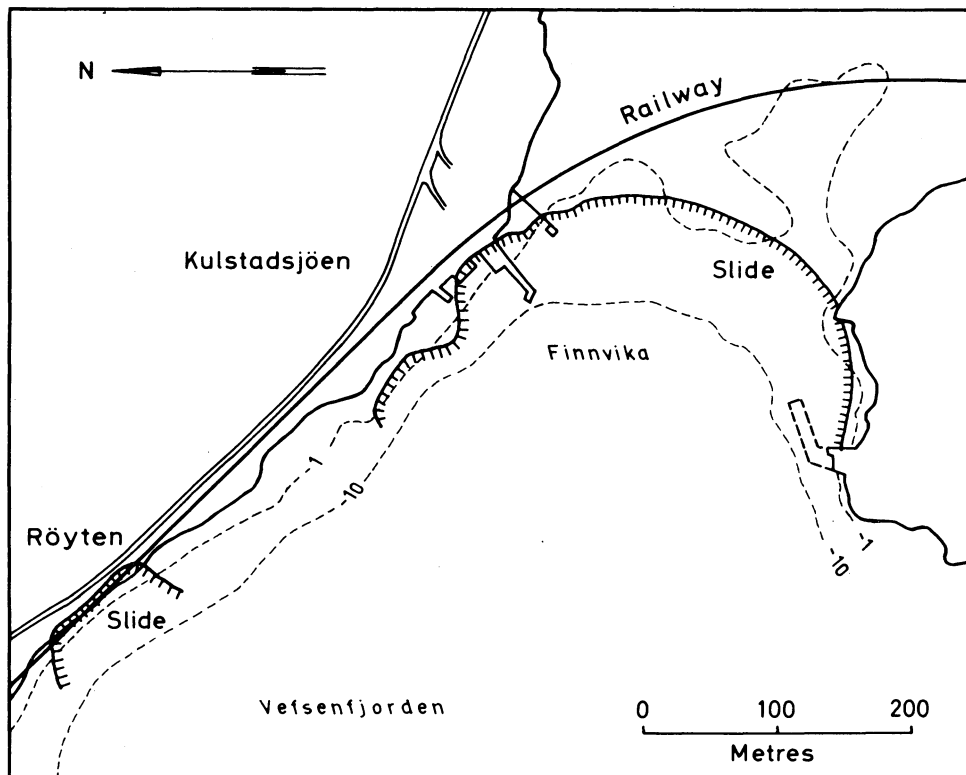
Fig. 6. Slide in Finn timer, August 31, 1940

About 5 minutes later the sediments forming the bottom of the interior part of the fjord of Finnviika were involved in a tremendous subaqueous slide (see Fig. 6) and disappeared together with a landing pier and a small commercial harbour. The slide caused an impressive wave which, a couple of minutes later, was observed to pass the site

The slide in Finnvik is very similar to the slide in Hommelvik only the dimensions are much greater. The initial slide was probably triggered off by the failure of the fill but high pore pressures in the nearby rock beneath the fill may have played a role in the instability.
