PORT AND OCEAN ENGINEERING UNDER ARCTIC CONDITIONS  
TECHNICAL UNIVERSITY OF NORWAY

CORROSION PROTECTION FOR STEEL SURFACES EXPOSED TO  
MOVING SEA ICE

Douglas H. Teeson  
Lieutenant

U. S. Coast Guard\*

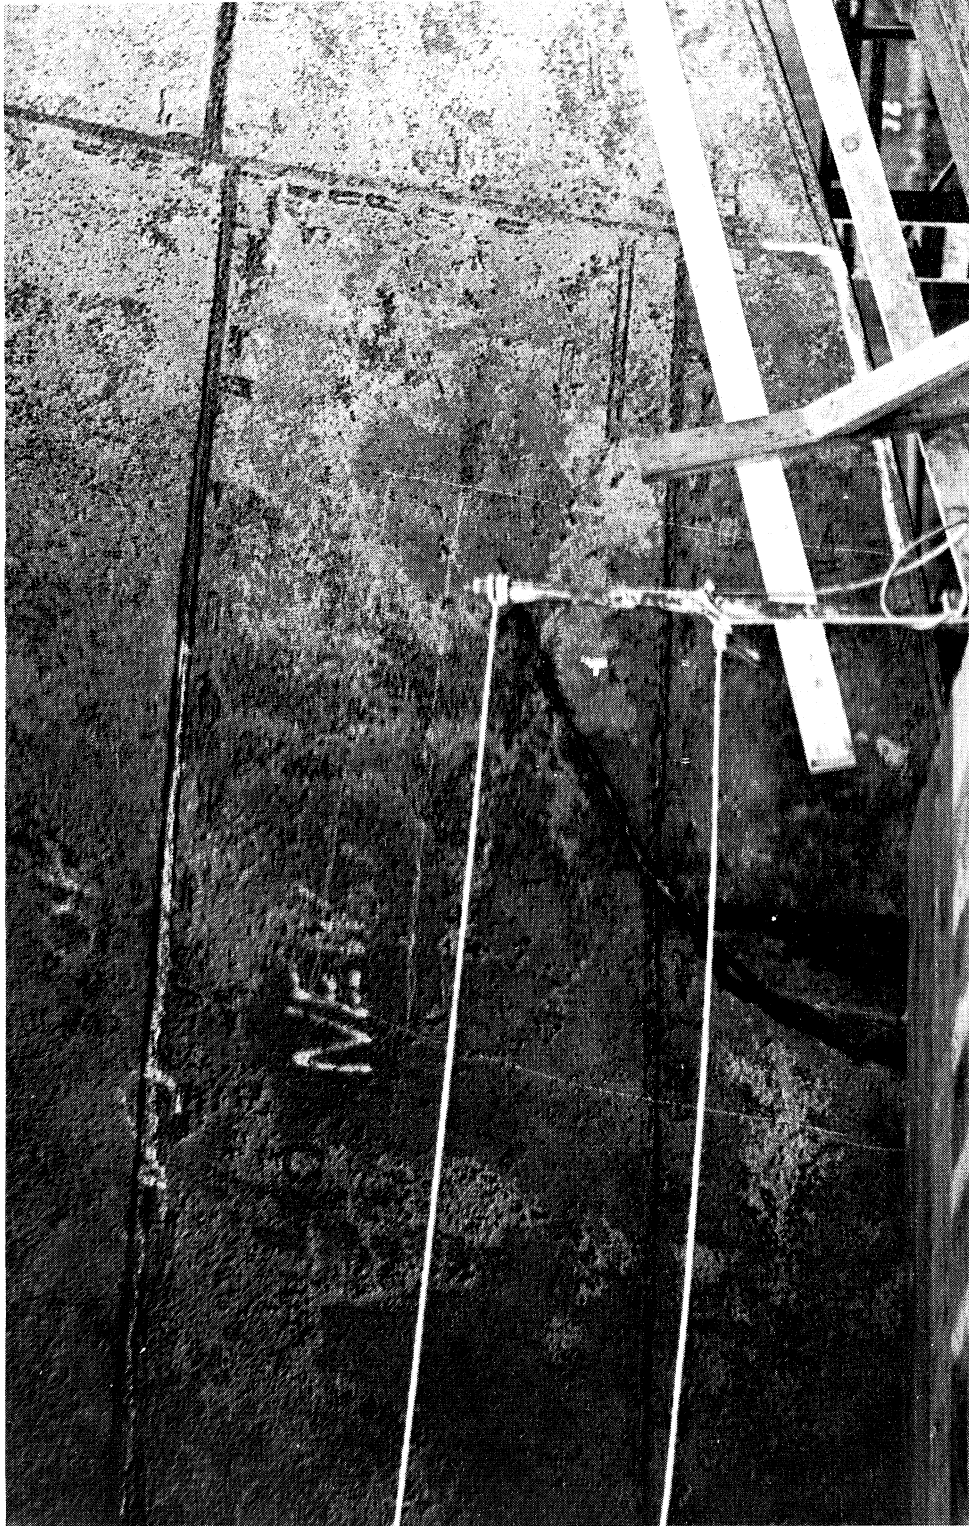
with a 1% nickel content. By the late 1960's all hull seams had been rewelded at least once. After the rewelding, the pitting attack appeared to shift to the hull plates. Concentrated pitting was noticed in the heat affected zones adjacent to the repaired seams and in the way of the builder's clips and brackets which were removed before launching by flame-cutting.

Accelerated corrosion in the heat-affected zones was probably due to localized variations in the grain structure of the steel caused by the heat of welding or flame cutting adjacent to the new welds and at the former sites of the builder's clips and brackets.

Figure 1: A and B strakes, starboard bow, USCGC NORTHWIND, November 1967. Although intended to show ice damage, this photograph illustrates well the extensive pitting of the shell plate, the corrosion of the original welds, and the concentrated attack in heat-affected zones caused by flame cutting the builder's clips and brackets.
