SECOND INTERNATIONAL CONFERENCE ON
PORT AND OCEAN ENGINEERING UNDER ARCTIC CONDITIONS
UNIVERSITY OF ICELAND
DEPARTMENT OF ENGINEERING AND SCIENCE

CORROSION OF MARINE STRUCTURES AT
GODTHAAB, GREENLAND.

E. Hulgaard &
Torben Sørensen
Civil Engineers,
Partners

Hostrup-Schultz
& Sørensen
Consulting Engineers

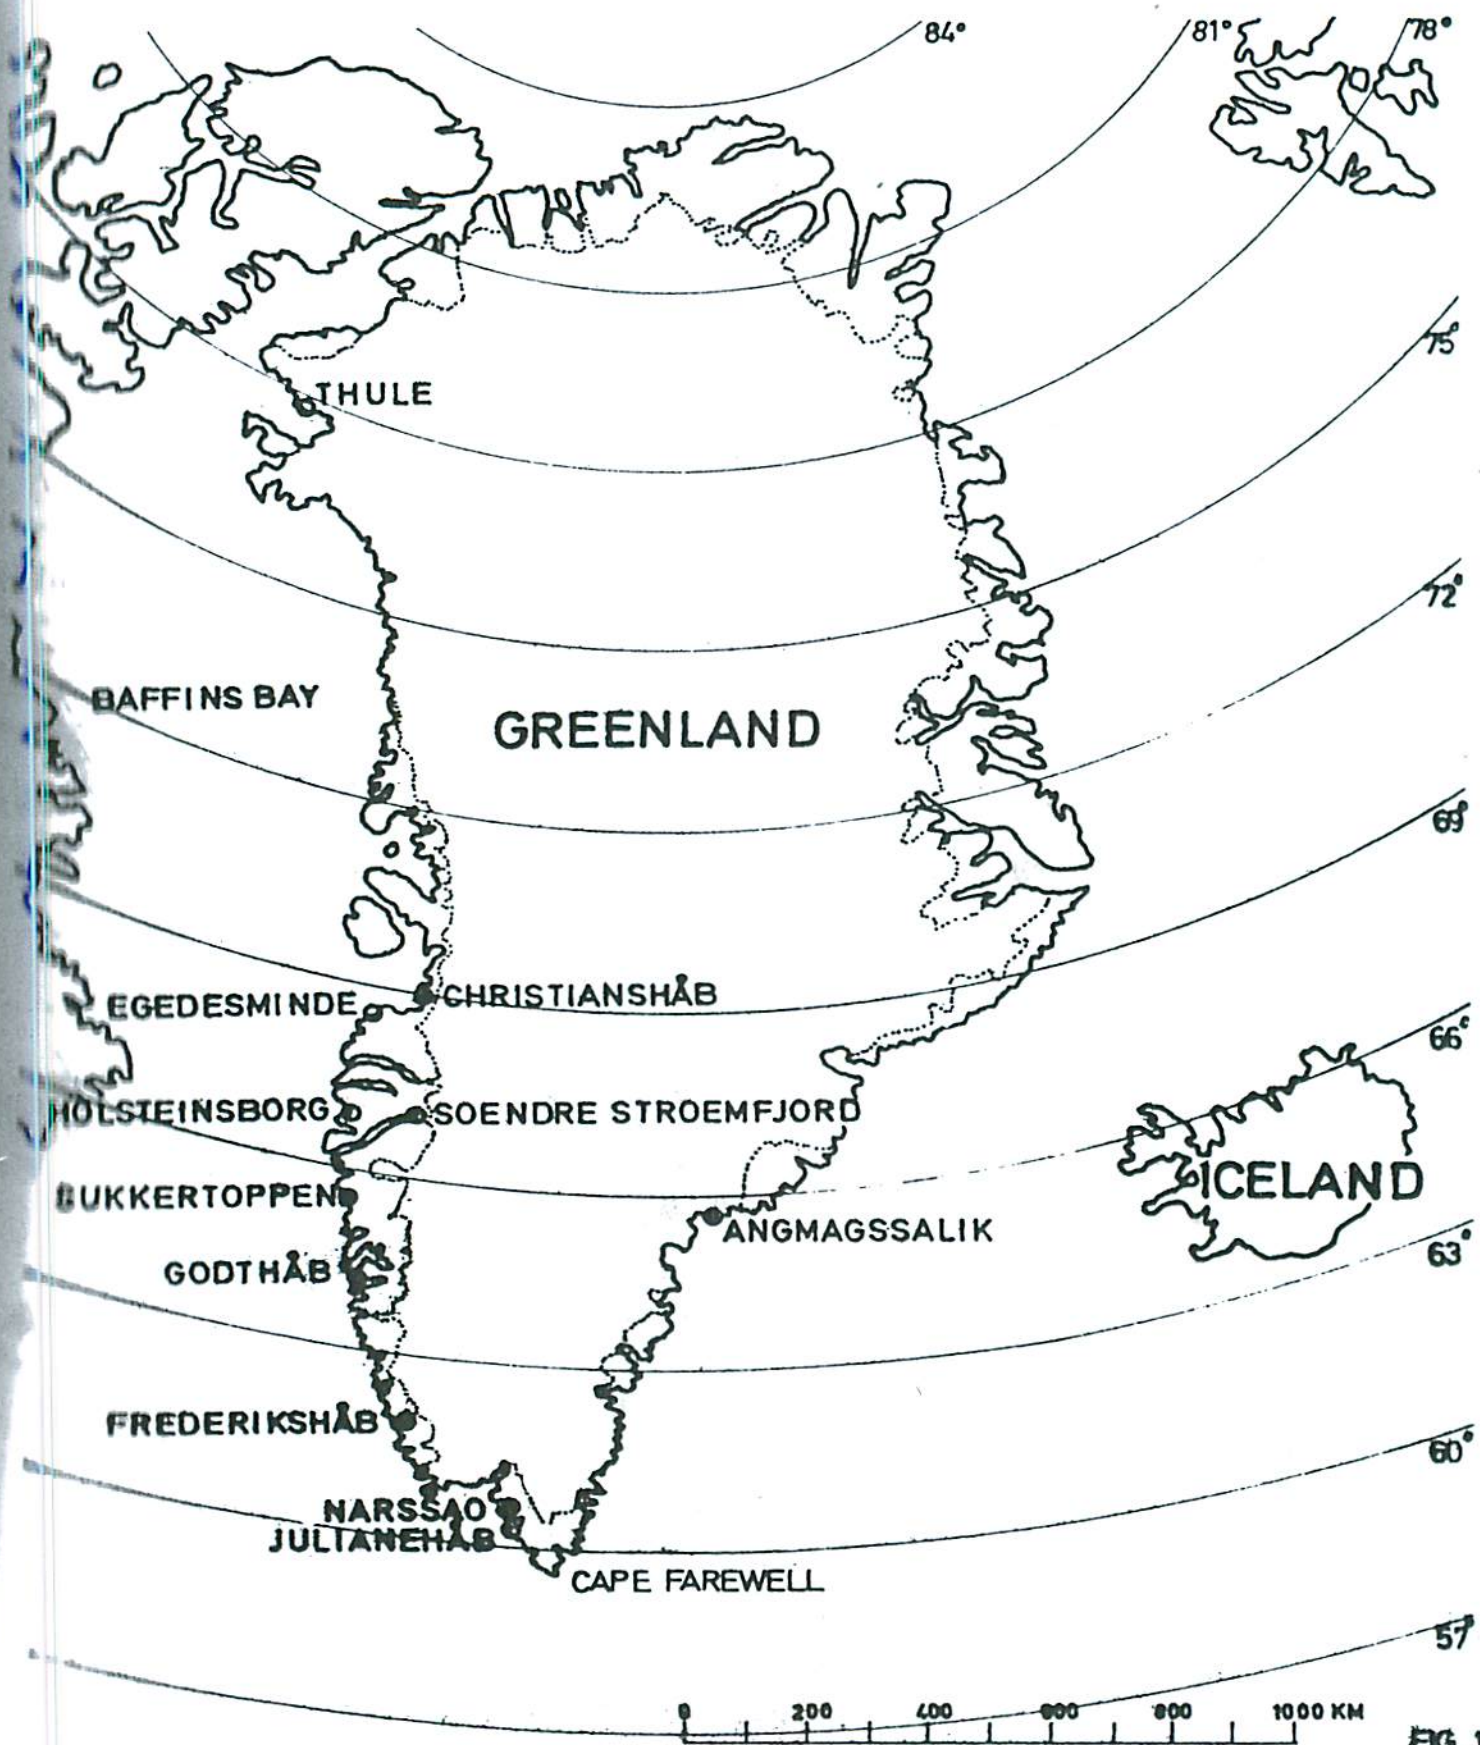
FIG. 1

In the past it has been believed by many that the cold temperatures and the clean water of arctic regions would cause steel corrosion rates to be less than in other regions of the world. To investigate this some corrosion measurements were carried out in 1972 in cooperation with GTO and the Danish Corrosion Institute. The study involved measurements of a steel pile of an existing wharf structure at Godthaab, Greenland, figure 1 and 2.

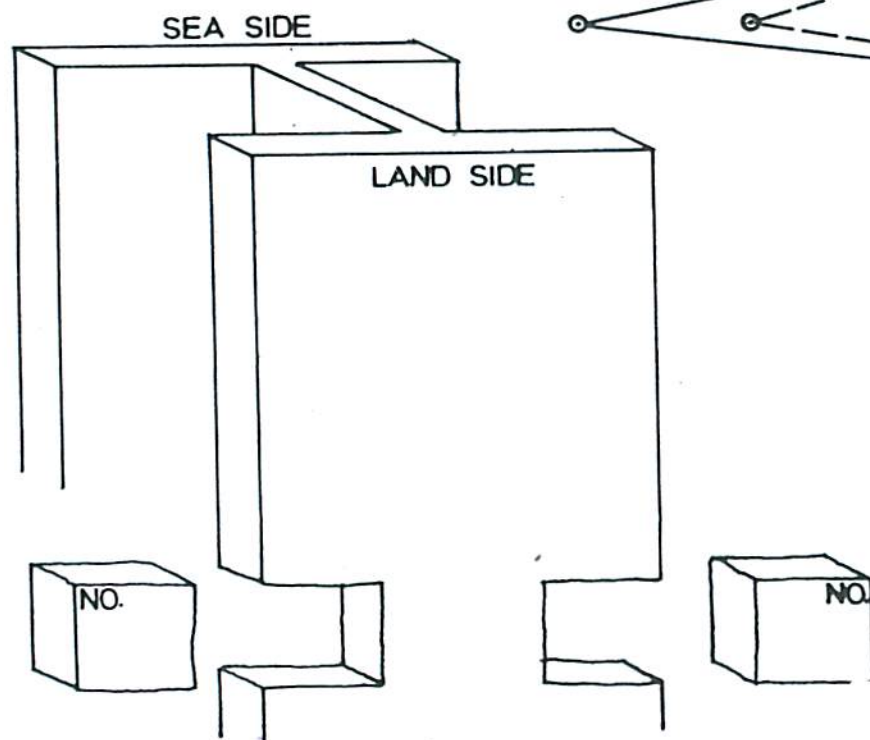
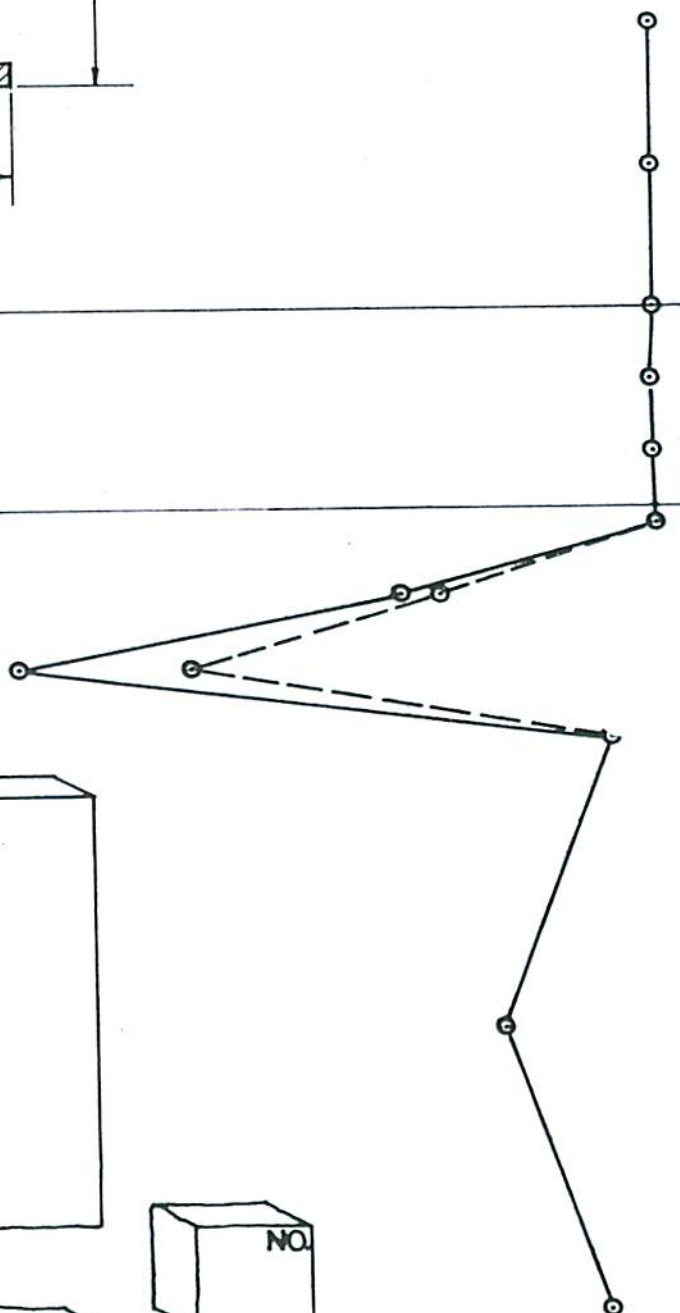
FIG. 4

The results of these investigations are shown on figure 4.

It shall be remarked, that the original thickness of the flange is supposed to have been 17 mm although the specified thickness is 18 mm.

The measurements show that the maximum corrosion occurs at a level $\div 2.0$ m to $\div 2.5$ m, which is 0.5 - 1.0 m below the mean low water level. In this zone the reduction of the flange thickness is up to 8.6 mm. For another pile the maximum reduction at level $\div 2.5$ was measured at 15 mm. Below $\div 2.5$ the corrosion is about 1-2 mm and above level $\div 1.5$ m it is only about 0.5 mm.

The corrosion did not normally occur evenly on the two sides of the flange. For the pile described above, the maximum corrosion from one side was 6.0 mm, corresponding to $\frac{6.0}{20} = 0.30$ mm/year.
