# **Behaviour of an Ice Sheet under Heavy Loading**

Volker Neth <sup>1</sup>, Dan Masterson <sup>2</sup>

<sup>1</sup>EBA Engineering Consultants Ltd., A Tetra Tech Company, Vancouver, CANADA

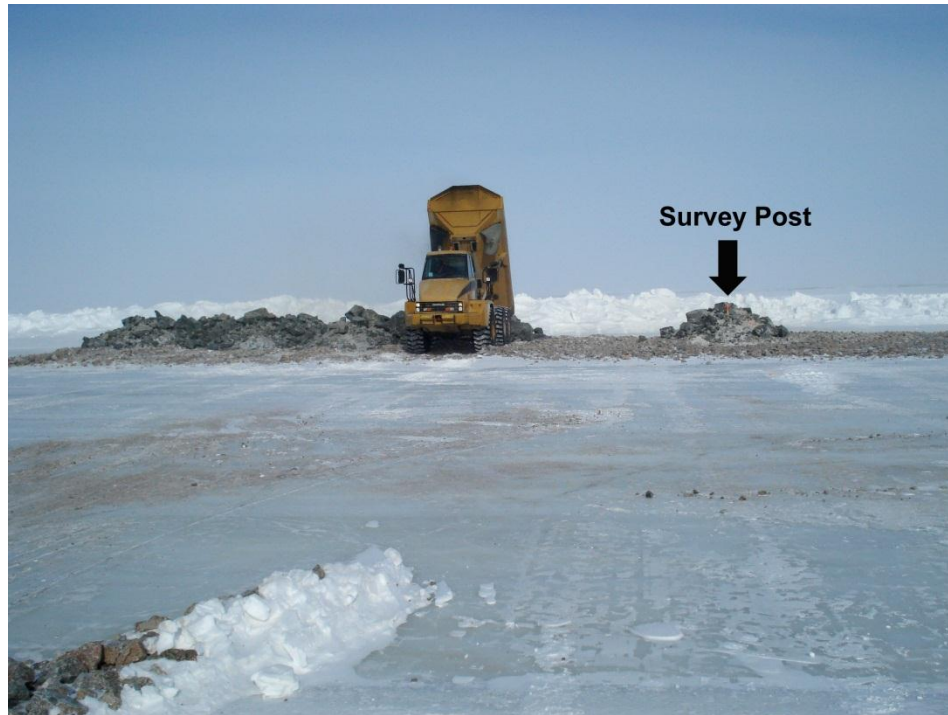
Different loading scenarios were applied depending on the shape of the shoal. In case of a near square shape, the first load was dumped in the middle of the shoal on top of the crushed rock as shown in Photo 1. A scaled wooden stick was planted among the rock for monitoring the shoal deflection. Deflection readings were taken and recorded following the placement of 2 to 3 truckloads. After the first load placement, loading of the shoal area was accomplished by placing material at both shoal ends and advancing towards the shoal centre as shown in Photo 1.

Photo 1. Rock shoal construction with survey post in shoal centre

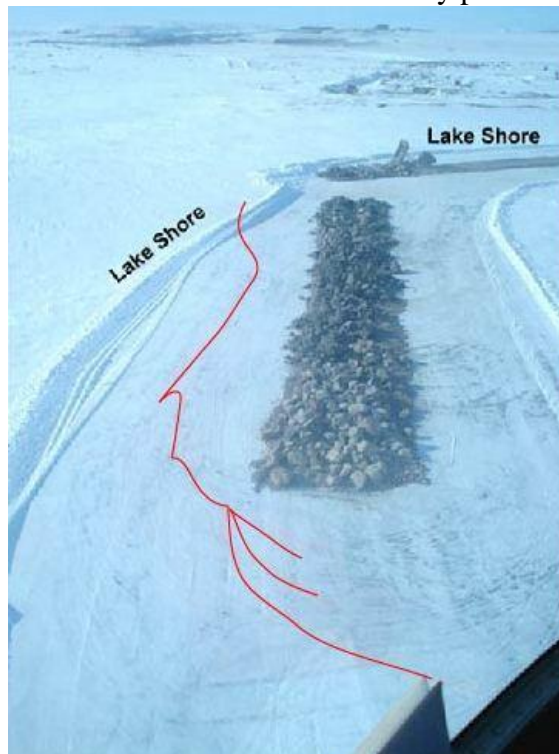
In case of a rectangular shaped shoal, placement of the ROM material started at one shoal end and continued towards the other end as shown in the background of Photo 2. In the foreground, a completed rock pile can be seen along with colored ice crack markings. Of interest is a large crack between the lake shore and the rock pile, which marks the boundary between ground fast and floating ice.

Photo 2. Completed rock pile with crack markings in foreground; rock pile construction in background

Following the placement of the initial few rock loads, the first dominant crack developed at the ground-fast ice/floating, ice interface due to the difference in support conditions. This initial crack opened up to 25 cm at some shoals with increased loading as shown at the centre of the shoal in Photo 2. This crack continued around the shoal ends away from the shoal. Smaller, circumferential cracks developed at higher loads parallel to the initial crack 8-10 m away on the other side of the shoal. These cracks did not connect forming on continuous circumferential crack. No radial cracks were found at any loading stage at any of the shoals.

During the placement of the first few loads, attempts were made to detect a "first crack" which could possibly have initiated a failure mechanism or yield line failure. In this failure mechanism radial cracks or "first cracks" propagate some distance away from the loaded area towards a circumferential crack. A completed circumferential crack most likely initiates an immediate breakthrough. The transition from the "first crack" to a breakthrough occurs normally faster in thinner ice. Peters et al. (1982) stated that thicker ice breakthrough may only be achieved, after additional load increments have been applied, following the development of the circumferential crack pattern. It should be noted and as shown in Photo 2, only "circumferential cracks" but no

radial cracks were observed during construction. The “circumferential cracks” did not connect into one complete crack around the shoal.

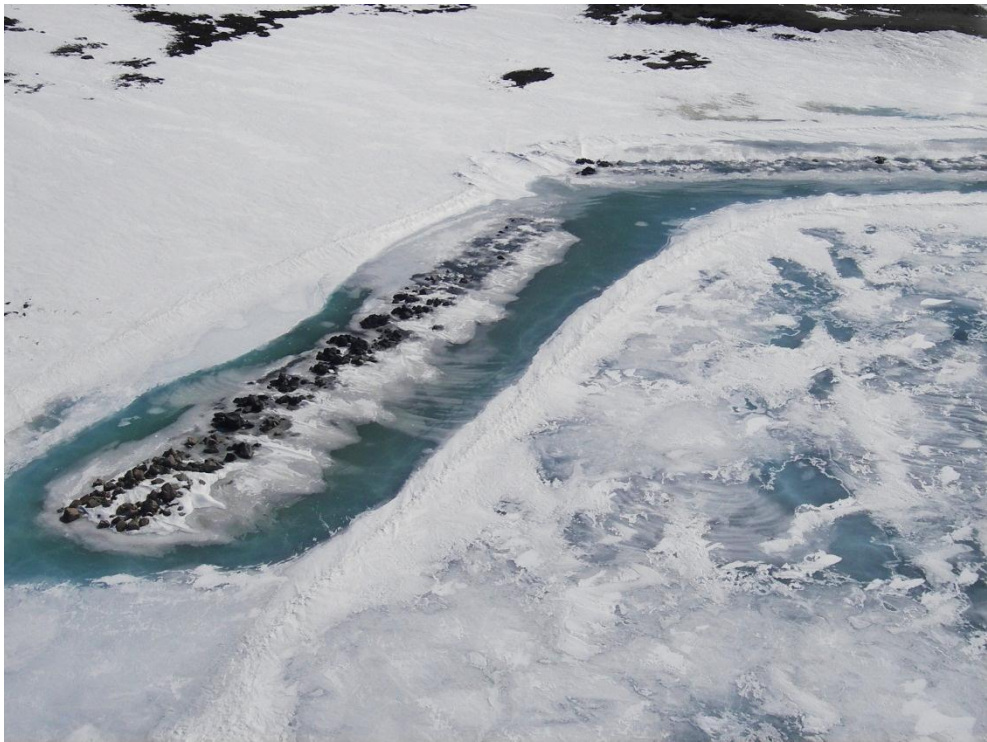
The same rock shoal is shown in Photo 3 at the end of May, before it went through the ice. Note the water accumulation around the shoal within a depressed ice cover.

Photo 3. Rock fish shoals, May 28

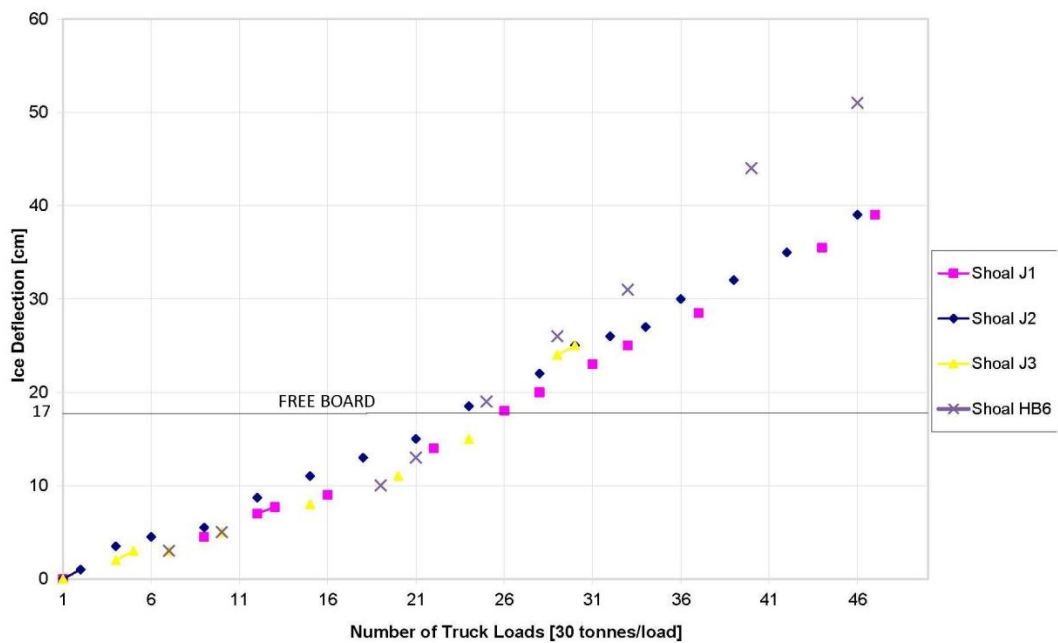
It was assumed that with each truck load 30 t of ROM material were added to the rock shoal pile. The construction time of one shoal varied between 7 and 10 hrs. depending on equipment availability. During loading, the truck number and the time at which the truck dumped its load were recorded along with the deflection reading. This enabled the observer to monitoring the behaviour of the ice sheet in real time by plotting the number of truck loads vs. deflection. This was done for three shoals at Jericho and one at Hope Bay (HB6) as shown in Figure 2. Of interest is that the four shoals follow initially the same trend. At about 30 loads, the HB6 deflections increase non-linearly due to delays in loading. Loading of shoal J2 was discontinued for about two weeks. As shown in Figure 2, ice deflections exceeded the available freeboard following the placement of about 50% of the ROM material.

Figure 2. Load-ice deflections during rock shoal construction

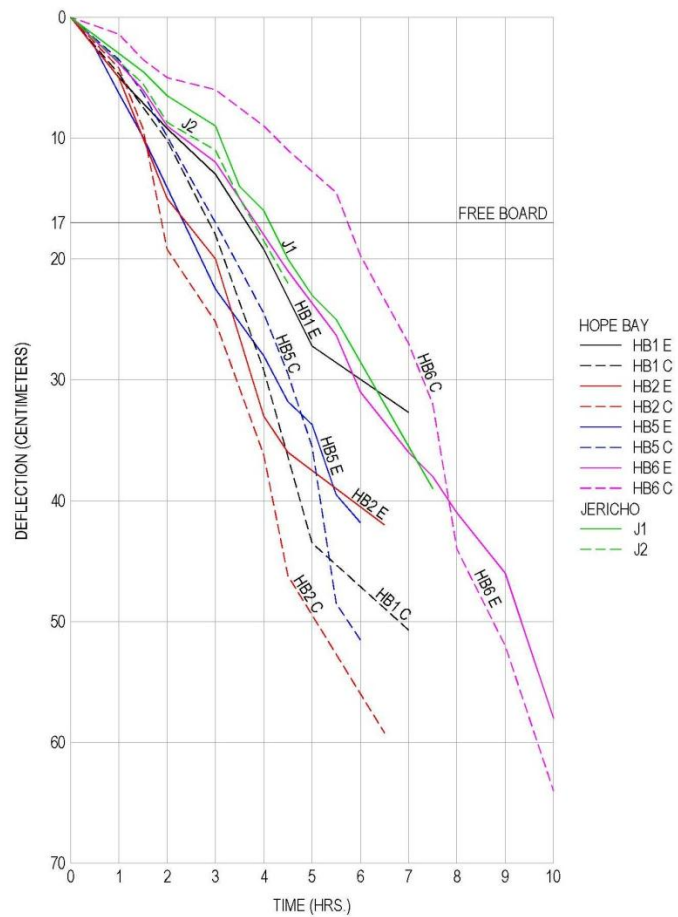
The same deflection data is shown in Figure 3 as a function of construction time. As mentioned above, it should be kept in mind that the ice sheet was loaded gradually. At Hope Bay, deflection measurements were taken at the end of the shoal (E) in addition to the centre location (C). It should be noted that at all time deflection curves (except HB6(C)) pass through the available FB level between two and four hours.

Within two to four hours following the start of rock placement, measurements indicated that deflections exceed the available freeboard as shown in Figure 3. The data confirms recommendations made in the Government of Alberta Ice Safety Guide (2009), which defines short term loading as a load which remains at one location on the ice for up to two hours.

Figure 3. Ice deflections vs. time during shoal construction

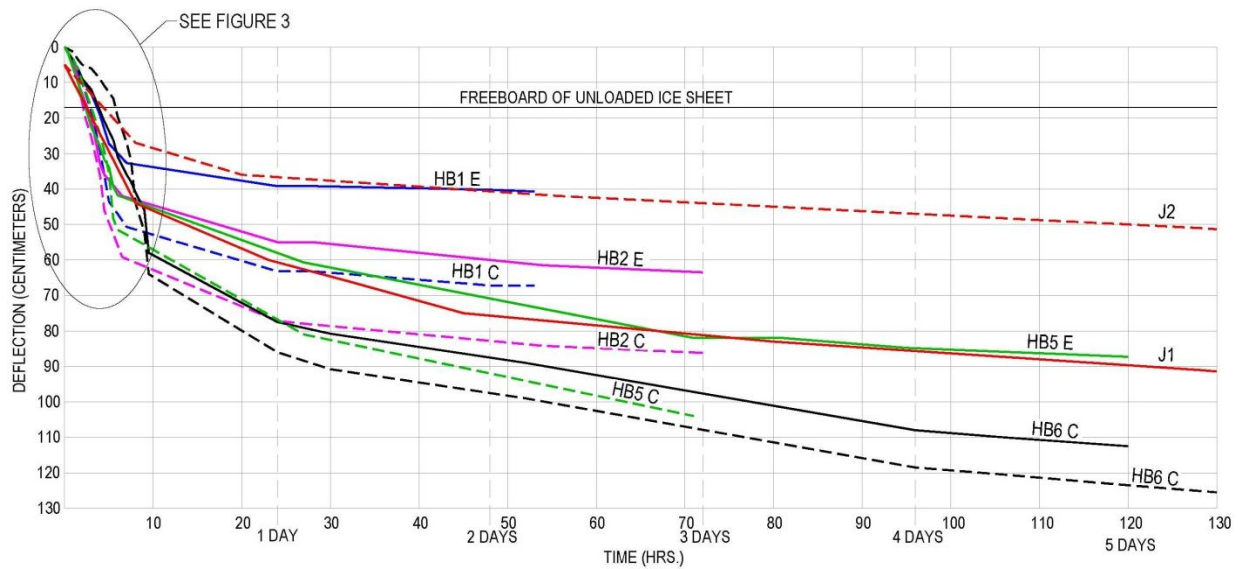
Following the completion of the shoal construction, daily readings were taken over a period of up to 17 days with the survey level remaining at the site. Occasional back site readings were taken to ensure the accuracy of the deflection measurements. Time/deflection data are plotted in Figure 4.

As expected and typical for all shoals is the change of slope deflection after the ice sheet was fully loaded. Long term deflections amounted to 25% and 100% of the initial deflection for shoals HB1 and HB6, respectively. Deflections at the Jericho site were measured at the shoal centre only. At Hope Bay, shoal deflections were monitored at one shoal end and the shoal centre. Centre deflections exceeded deflections at the shoal end. Only during initial loading, higher end deflections were recorded at some shoals as the result of the loading sequence. In these cases, loading commenced at the shoal ends and was completed at the shoal centre.

Following the completion of rock placement, the ice sheet continued to deflect through creep. With no water seeping through cracks onto the ice surface, more water was being displaced with increasing deflection. As shown in Figure 4, some shoal ice depicted little or no deflection increase indicating a steady state. In other instances, creep deflections were as large as deflections obtained during construction.

Figure 4. Rock shoal ice deflections vs. time
