SECOND INTERNATIONAL CONFERENCE ON
PORT AND OCEAN ENGINEERING UNDER ARCTIC CONDITIONS
UNIVERSITY OF ICELAND
DEPARTMENT OF ENGINEERING AND SCIENCE

UNDERWATER LABORATORY IN SUB-ARCTIC WATERS

J. English
Project Engineer
R. T. Dempster
Associate Professor

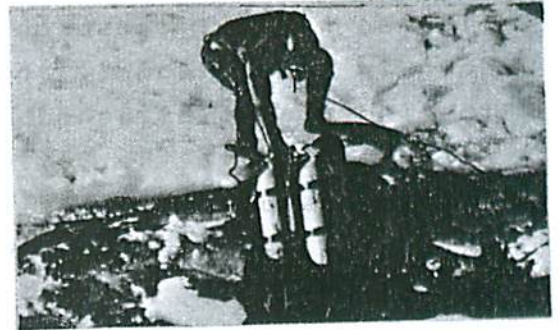
Figure 1.
ICE DIVING

The dynamic nature of the ice found in Newfoundland, and the speed with which conditions change, make diving in and around ice extremely dangerous. Diving procedures must be adapted to meet the particular circumstances encountered. For example access from shore is limited since the slush density is such that the diver loses mobility to the point where it becomes dangerous. Heavy slush retards small craft movement and can completely stop it. Loosely packed ice pans present no major access problems, as boats and divers can route through natural openings. The danger arises in the ever present, and highly likely possibility that wind shifts will pack the flows together entrapping the diver. A tightly packed field will support divers and equipment but it is extremely difficult to keep a hole open once one has been made. Heavy arctic ice and growlers pose a serious threat to boats and the habitat itself. To the divers, the most serious threat is breaking ice or instability which could cause the mass to roll over on them.

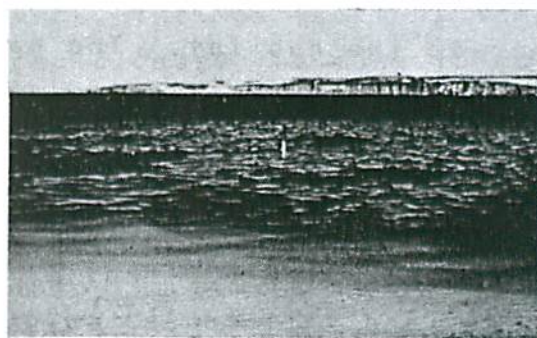
Figure 3
SLUSH LAYER

From early to mid December, water temperatures fall steadily until they reach -2°C . The temperature remains sub-zero until spring. The first signs of ice are the freezing of the river fed harbour area, and the appearance of a thin "oily" layer of slush in the cove. Sustained on-shore winds compress this layer horizontally and it becomes visible as a grey slush lining the shore. By early February the slush layer will extend 200 to 300 feet from shore and be 2 to 3 feet thick at the shore. The near shore slush has a very grainy texture, with solid ice particles suspended in it. This gradually changes as one proceeds from shore, with the outer portion of the layer giving the water a glassy appearance. The layer is dense enough to retard boat traffic and damp wave action, reducing wind chop to rolling swells. The density and expanse of the layer increases until, by mid February, it begins to consolidate and large pans form. The ice will extend one to three miles from shore and vary in thickness up to eight inches. By the end of February, the slush layer is no longer observed and evidence of local rafting is noticed.

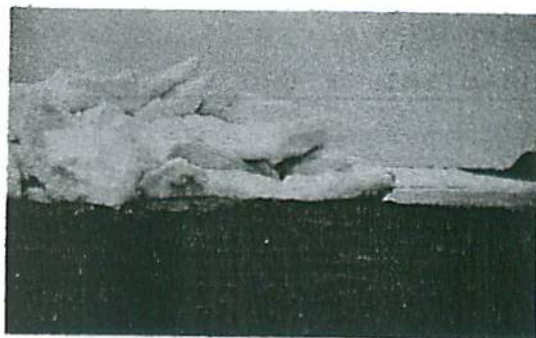
Figure 5
GROWLER

Growler ice was responsible for severe bottom scouring and damage to the habitat structure. The composition of a growler can best be described as being a mass of rafted ice. This mass consists of a "main" plane, composed of a single or composite pan, in a near horizontal position, at water level, with smaller pieces of ice heaped at assorted angles above and below. The surface mass appears rather loosely packed with voids and snow filled spaces between the hunks. The sub-surface mass is composed of similar pieces, with the major difference being that the total mass is much greater than the surface counterpart. The average thickness of the pieces in both masses is of the same order as that of the sheet making up the main plane. Also the ice pieces in the

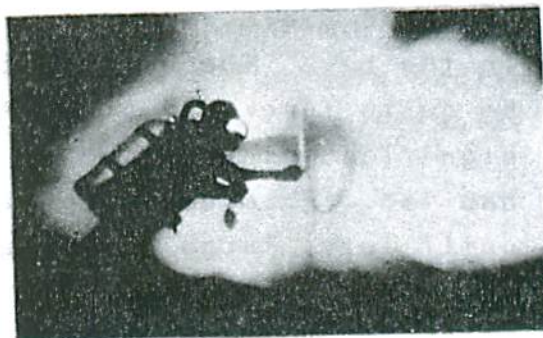
Figure 6.
UNDERWATER FEATURE OF
A GROWLER

The underwater profile of the ice is quite irregular with tunnels, indentations and sharp protrusions. Late in the season, the local features became well rounded but the overall shapes remained typical.

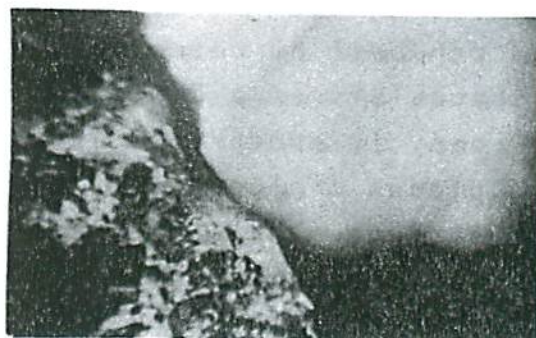
Figure 7.
ICE ROCK INTERFACE

Isolated growlers, entering the cove, normally were affected by wind and current and contacted ledges and outcrops around the perimeter rather than grounding in the middle of the cove. These pieces proceeded in deep water until their leading edges contacted a ledge. Wind and wave action held them in a state of dynamic contact with the rock. The horizontal component of the roughly orbital motion appeared the largest and the result was a regular, audible impact. The impact, which was over a small area due to surface irregularities, resulted in the rock face being shattered, scraped clean of encrustations and marine life, and left with a rather polished appearance.

No appreciable wear was apparent on the ice, although small bits of stone and seaweed were imbedded in it. The observation periods were relatively short, and measurements will be required to determine ice erosion.

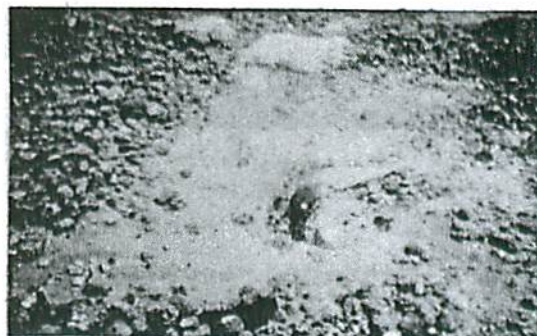
Figure 8.
SAND PIT

In sandy areas, gouging and pitting was observed. The pits were 6 to 10 inches deep and 3 to 5 feet in diameter and were apparently caused by sharp protrusions settling into the bottom. Nowhere in the area was there evidence of a continuous gouge or track being caused by a steady progression of a single piece of ice. The size of the ice, surface condition, and the tidal influence would prevent this occurrence.

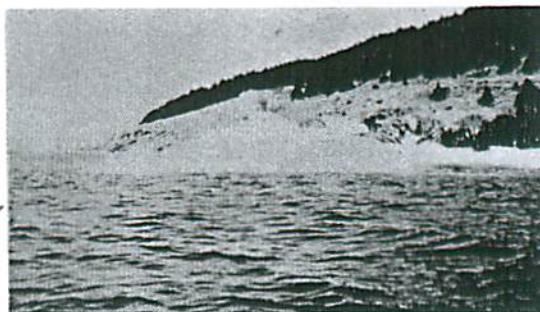
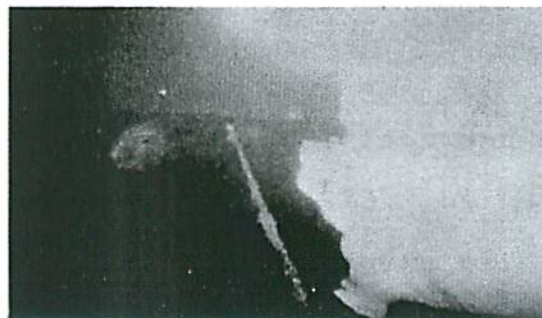
Diving and photography commenced immediately and the ice was observed as it contacted the cables and subsequently moved inshore. The leading edge of the ice contacted the inshore, forward guy wire and remained in contact. The ice motion caused the rock bolt to flex and relax, introducing some spring in the cable. The ice, under continuous wind stress, pivoted around the point of contact and was left orientated along the side of the habitat completely covered and surrounded on one side and one end. The ice rode slowly up and down on the two cables. At this time, the ice was also contacting the bottom at several points directly under its mass. A gradual wind shift moved the ice inshore and the structure was no longer in danger.

Figure 9.
GROWLER

Figure 10.
GROWLER ON HABITAT

There was no failure of the hardware involved. None of the rock bolts were pulled free of the rock into which they were placed. There was no geological failure associated with the cables terminated in bedrock. Underwater observation showed that the cables formed a spring system which caused the ice to deflect from the structure.
