SECOND INTERNATIONAL CONFERENCE ON
PORT AND OCEAN ENGINEERING UNDER ARCTIC CONDITIONS
UNIVERSITY OF ICELAND
DEPARTMENT OF ENGINEERING AND SCIENCE

ICEBREAKING BY TOW ON THE MISSISSIPPI RIVER WITH
MV RENEE G

Corps of Engineers
U.S. Army Cold Regions
Research and Engineering
Laboratory

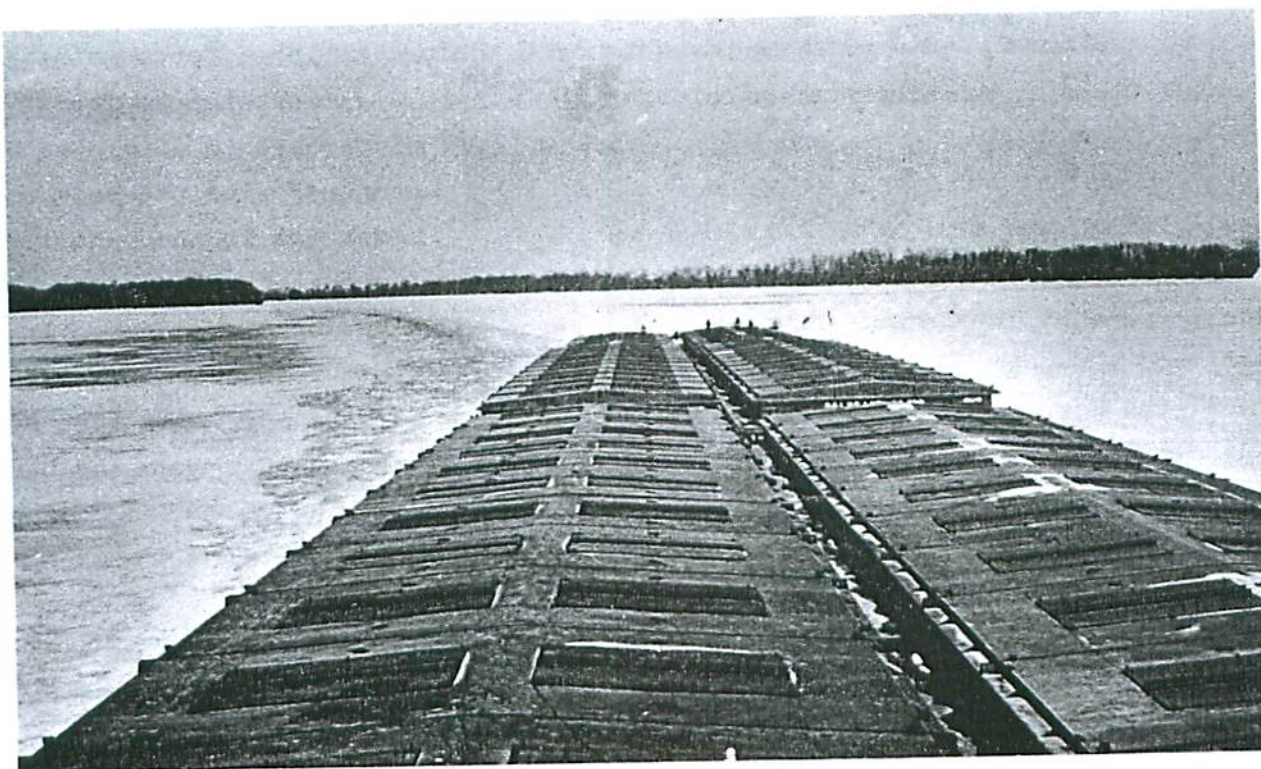
Figure 3. Pushing barges ahead.

in Figure 2 is the Renee G alone, as it was occasionally used "bare boat." During normal operation (barges ahead of towboat as shown in Figure 3) the barges and towboat were rigged together with 7/8-in. diameter wire cables by means of

face lines (either two or four part) on each side of the bow of the towboat. Each face line ended in a power winch that was used to tighten the cables. During the icebreaking tests with load cells installed between the towboat and the barges two additional criss-cross wires were used to minimize lateral movement of the barges.

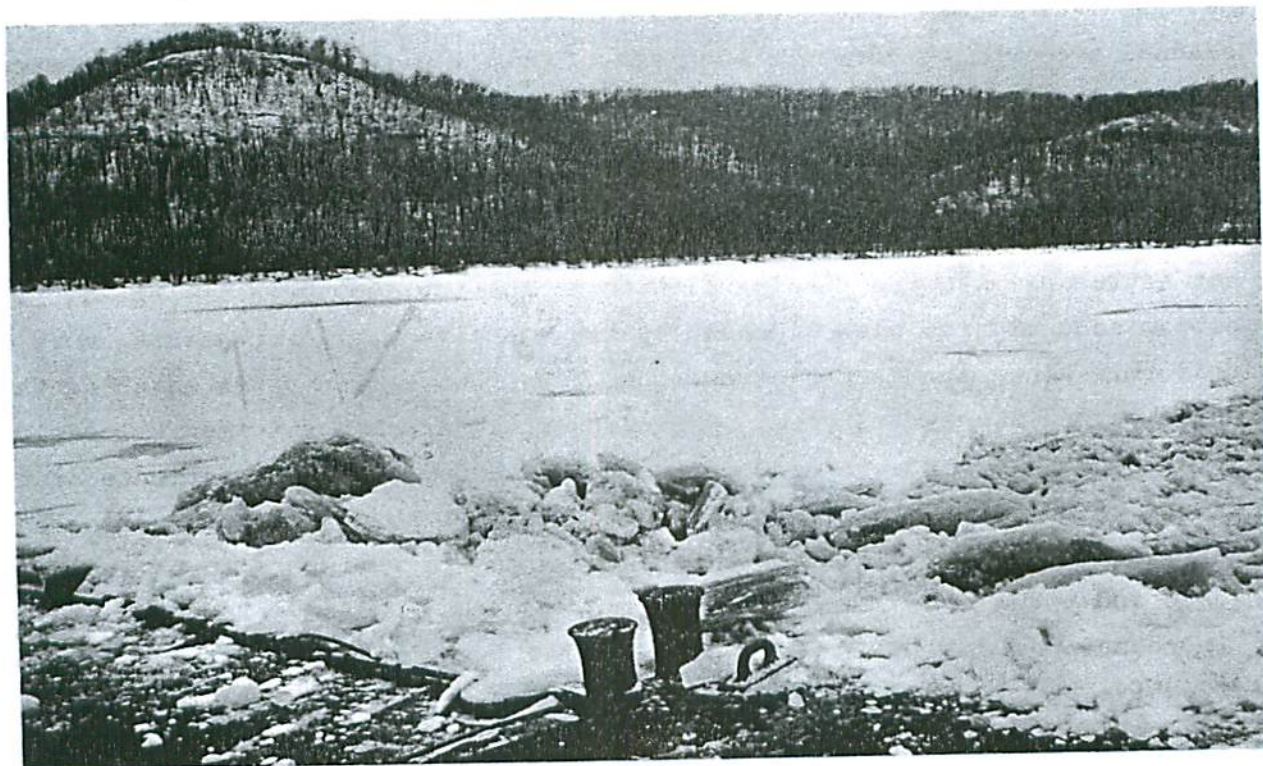
Figure 5. Brash ice piled above bow of barges.

Just ahead of the bow the brash tended to pile up, often above the front deck of the lead barge, resulting in some cases in spillage onto the bow (See Fig. 5). More often, however, the pile did not exceed the bow deck height but was

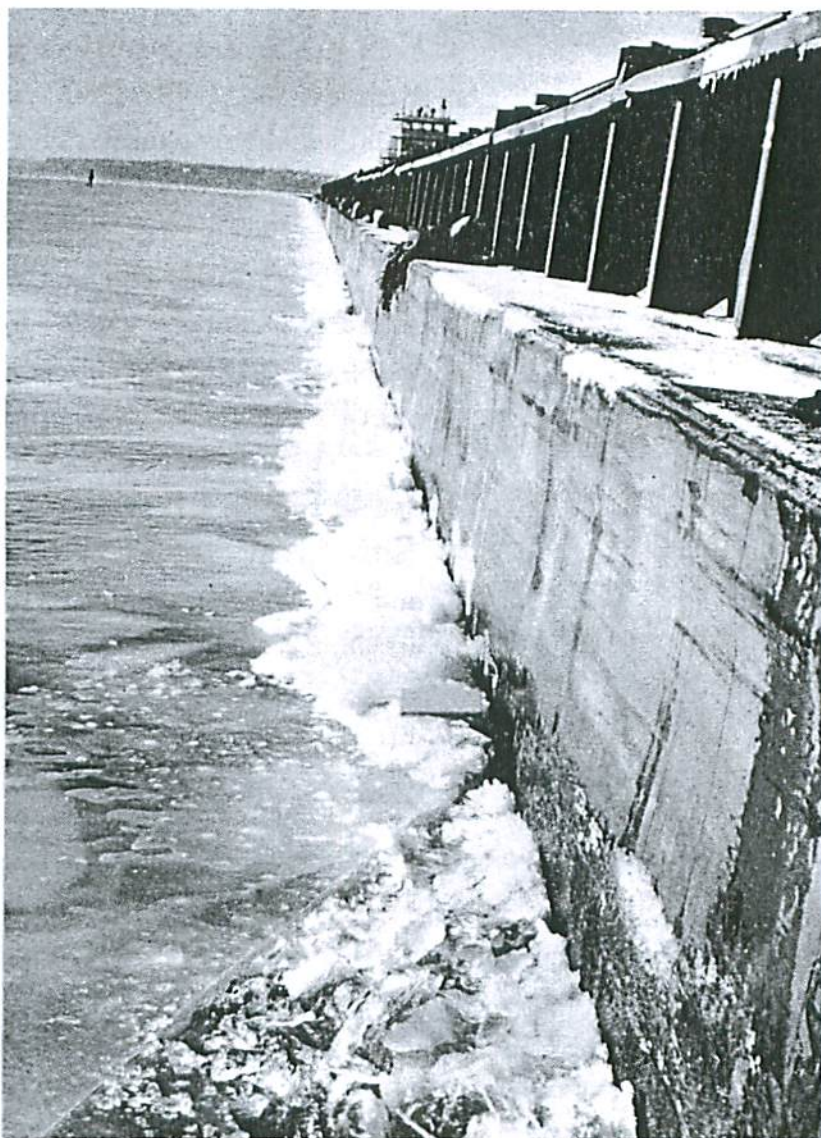
Figure 6. View of ice along sides of barges during passage through an unbroken ice cover.

As the barge moved forward the ice bent downward and passed beneath the bow. While the barge was moving through the ice, lateral fracturing could clearly be seen just ahead of the barges. Little cracking outward from the sides of the barges was observed and the barges cut a "clean" path through the ice, only slightly wider (a few inches at most) than the tow width. The cleanly cut edges and relative lack of disturbance of the ice outward from the sides of the barges are clearly shown in Figure 6. There was no observed tendency for the barges to "ride up" on the ice sheet in front although the Captain said this sometimes occurs with empty barges in "heavy" ice, particularly consolidated thick brash.
