Erosion protection of a coastal cultural heritage in Svalbard; "Fredheim"

ABSTRACT

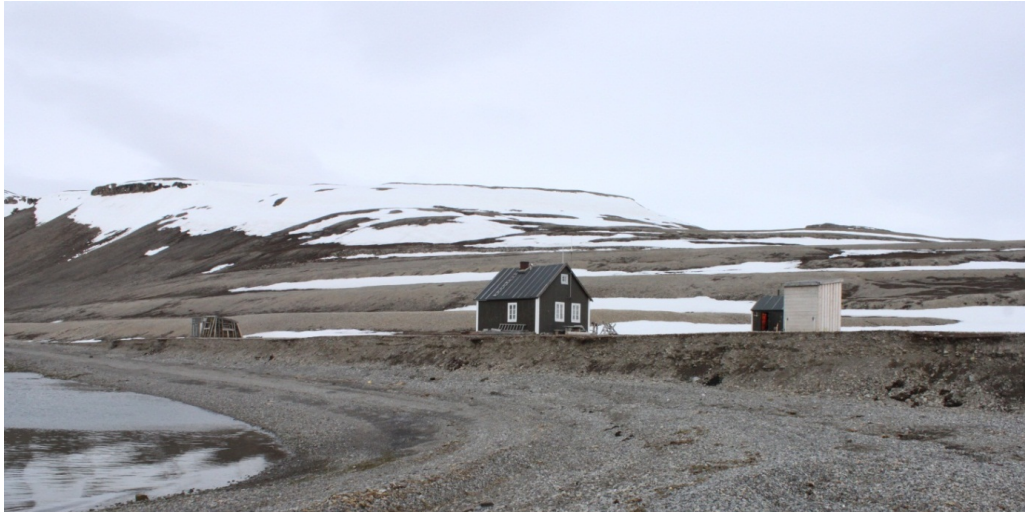
Figure 1. Fredheim as seen from the west (Photo: SINTEF).

Fredheim, see Figure 1, a cultural heritage site existing of four different cabins used by trappers in the early 19th century, is located in the inner part of Isfjorden, Svalbard, see Figure 2. The site undergoes active erosion and is interesting for research on coastal erosion rates and mechanisms of permafrost soils. A description of the geology of this area can be found in Sessford (2013).

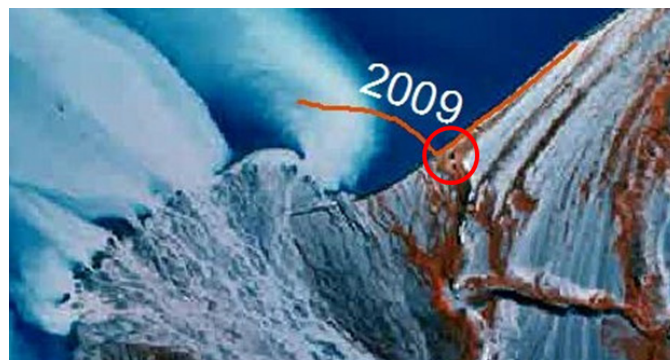
Figure 3. Nøis River delta in 1990. Brown line represents northern part of delta and escarpment edge in 2009. (Image adapted from Norsk Polarinstitutt image S90 2207).

The houses at Fredheim are located on the northern side of the Sassen valley, and in front of the Nøis River delta (Figure 3) which is continuously changing form and size. These deltaic changes will affect the coastal erosion situation at the site considering the role of sea waves as a part of the erosion process.

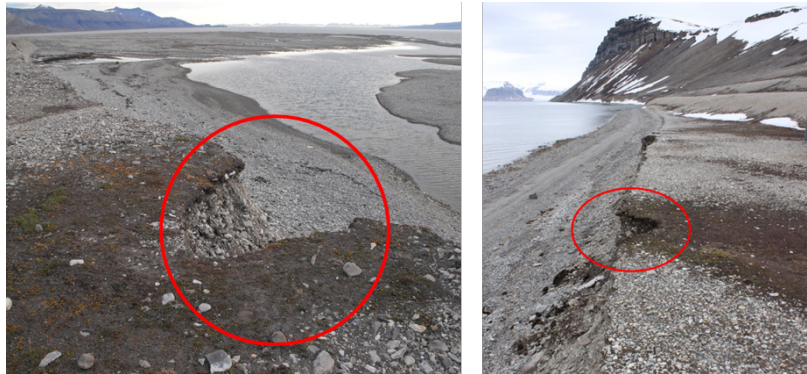
Figure 5. Zone with water channels and leached soil.

The tables above (Table 2 and Table 3) show that there are variations in erosion rates between the erosion edge and the individual houses. This can largely address the erosion mechanisms of Fredheim. It has previously been believed that the erosion was strongly linked to wave erosion, but the findings presented in this paper indicate that this might not be the case. Waves are a contributing factor, essentially as a carrier of already eroded soils. The main erosion process is melting and sliding of permafrost soil where nivation channels are probably the major contributor for this site (Figure 5). In these channels, fine grains are washed out and the bluff/coast line becomes more unstable in this area. This process makes the area between channels also become more unstable due to reduced lateral support.

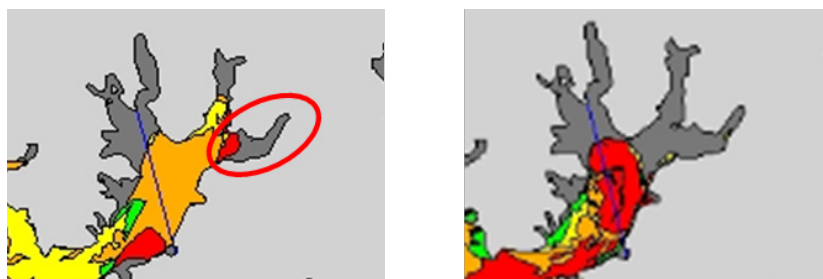
Figure 7. Sea Ice Map 1st of February and 1st of March 2011 (source: Norwegian Metrological institute).

the dynamics associated with tides, can affect the erosion rate; in the same way that snow in the coastal zone will affect the temperature regime in the coastal permafrost, and thus affect erosion rates. All these factors are interesting and similar measurements and observations will be included in the 2013 field survey. Ice Map observations related to the ice in The Sassen Fjord and The Tempel Fjord are presented in Figure 7 and Figure 8.

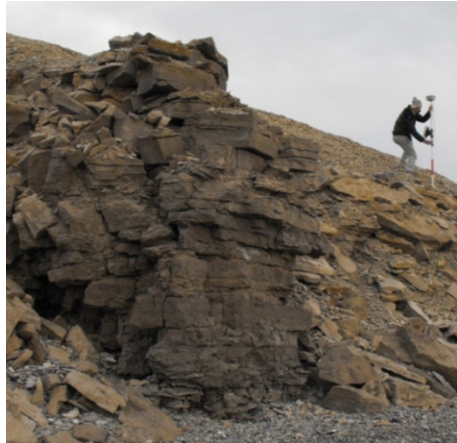
Figure 10. Bedrock sample area.

For recommendations of erosion protection methods and design, a number of different analyses were carried out in 2012 (Finseth et.al 2012). Grain size distribution was found for the soils (Table 4), while bedrock quality was tested and analysed by use of the Q-system (Table 5). Soil samples were taken both from the seabed and the bluff.
