FULL-SCALE MEASUREMENTS ON BOARD PSRV S.A. AGULHAS II IN THE BALTIC SEA

Mikko Suominen ¹, Jouko Karhunen ², Anriëtte Bekker ³, Pentti Kujala ¹, Mikko Elo ⁴,
Rüdiger von Bock und Polach ¹, Håkan Enlund ⁵, Sami Saarinen ⁴

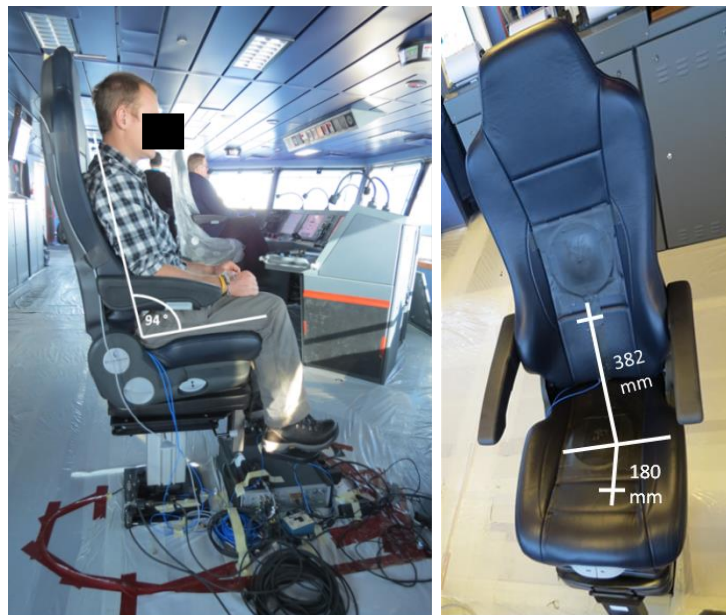
Figure 2. A seated occupant on the Cleeman seat on the bridge of the vessel (on the left) and the placement of the seat-pad accelerometers for whole-body vibration measurement (on the right).

Whole-body vibration comfort measurements were performed for a seated person on the Cleeman Dolphin seat, which is located on the bridge of the vessel (see Figure 2). The

translational acceleration was measured in the vertical (Z), longitudinal (X) and lateral (Y) directions on the seat-mounting bracket which is bolted to the floor of the bridge. Acceleration measurements were also recorded on the interfaces between the occupant and the seat where vibration enters the human body. The measurements were based on a basicentric coordinate system for a seated occupant, as recommended by ISO 2631-1:1997 (ISO 2631-1:1997/Amd 1:2010). The measurement locations include tri-axial measurements on both the seat backrest (382 mm from the plane of the seat-seat) and the seat-surface (180 mm from the plane with the backrest) and a perpendicular (almost vertical) measurement on the seat footrest (see Figure 2). Recordings were made at a sample rate of 256 Hz using LMS TestLab 10A Spectral Testing software and a LMS SCADAS multi-channel data acquisition system. The duration of the reported measurements are limited to 16 seconds to enable the comparison of vibration levels with associated vessel manoeuvres.

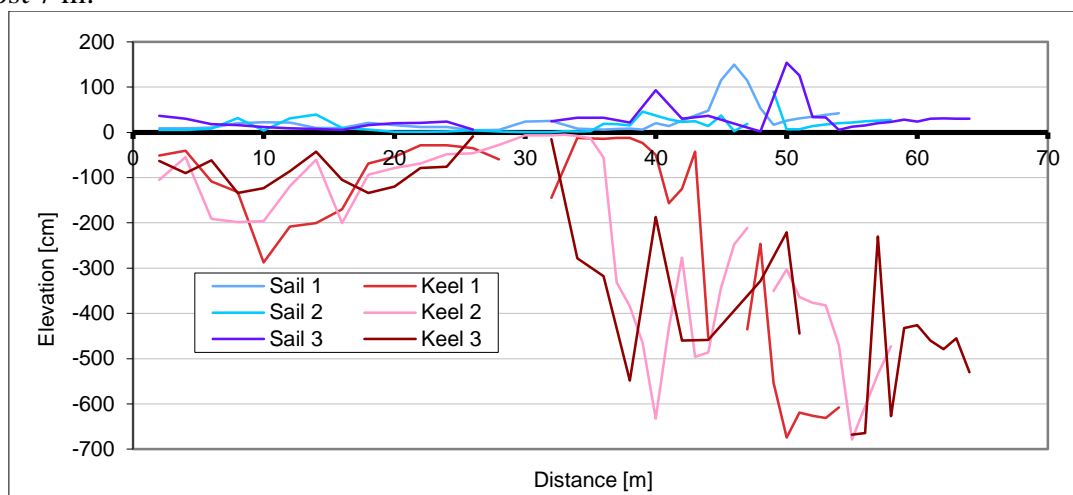
Figure 4. The profile of the ridge.

As mentioned above, one ridge penetration test was conducted. The ridge profile was measured along three different lines ranging from one side of the ridge to the other side. The distance between the lines was 15 meters. The cross-sectional profile of the ridge was determined by drilling through the ridge with a motorised drill. The profile was measured at every one to two meters along the lines. The sail height and the freeboard of the ice were determined with a laser leveling device and by measuring the distance between water level and ice surface from the drilled holes with a 'beeper'. The profile of the ridge is presented in Figure 4. The sail height was found to be a maximum of 1.3 m and the keel reached a depth of almost 7 m.

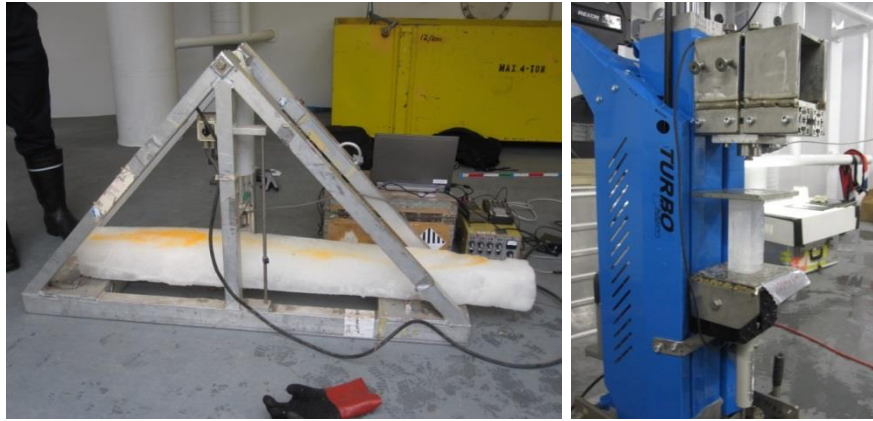
Figure 5. Test setup for obtaining ice flexural strength (left) and compressive strength (right) measurements.

The samples for the flexural and compressive strength tests of ice were taken from approximately 40-cm-thick level ice at three different locations. The ice beams were cut from the ice field, lifted on board the ship and trimmed for the tests. The flexural strength of the ice was measured by performing three-point bending tests in an A-frame test rig. The beam was simply supported on both ends and it was loaded downwards from the middle. The force needed to break the beam was measured with a force transducer. The measurement setup is shown in Figure 5. The flexural strength of the ice (σ_f) was calculated from the measured force using beam theory at the center of the beam as follows:

The compressive strength of the ice was measured by crushing the trimmed samples with an electric compressor (see Figure 5). The force needed to crush the ice sample was measured with a load sensor attached to the clamp. The compressive strength is determined by dividing the maximum force by the cross-sectional area of the specimen. The compressive strength of ice was determined for the vertically and horizontally orientated specimens. The compressive strength varied between 0.65 and 1.98 MPa in the horizontal direction and between 1.41 and 2.79 MPa in the vertical direction, while the average compressive strengths were 1.28 and 2.02 MPa in the horizontal and vertical directions respectively. The measured values are typical for one-year brackish water ice. The results are presented in Table 2.

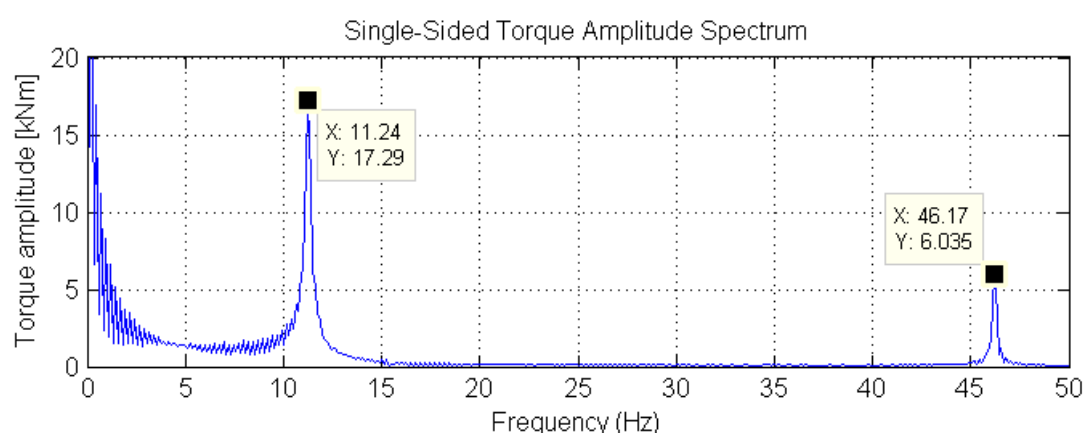
Figure 7. The lowest natural frequency of Torsional vibration 11.24 Hz visible in a measured spectrum.

The thrust, torque and rotational speed of the propulsion shaft were measured. When the propeller blade hit a piece of ice, this shock excited the natural frequencies of the system. Figure 7 presents the excitation of the first (11.2 Hz) and second (46.2 Hz) torsional vibration modes. In a similar way, other natural frequencies can be found from the measured spectrums. During the design phase of the vessel, the natural frequencies of the propulsion system were calculated. A comparison of the calculated and measured natural frequencies is presented in Table 3. The measured natural frequencies seem to be a little lower than the calculated values. This is caused by damping and the mass of water, which rotates or moves with the shaft and propeller. In addition, the calculation model which has been used may have too few degrees of freedom.

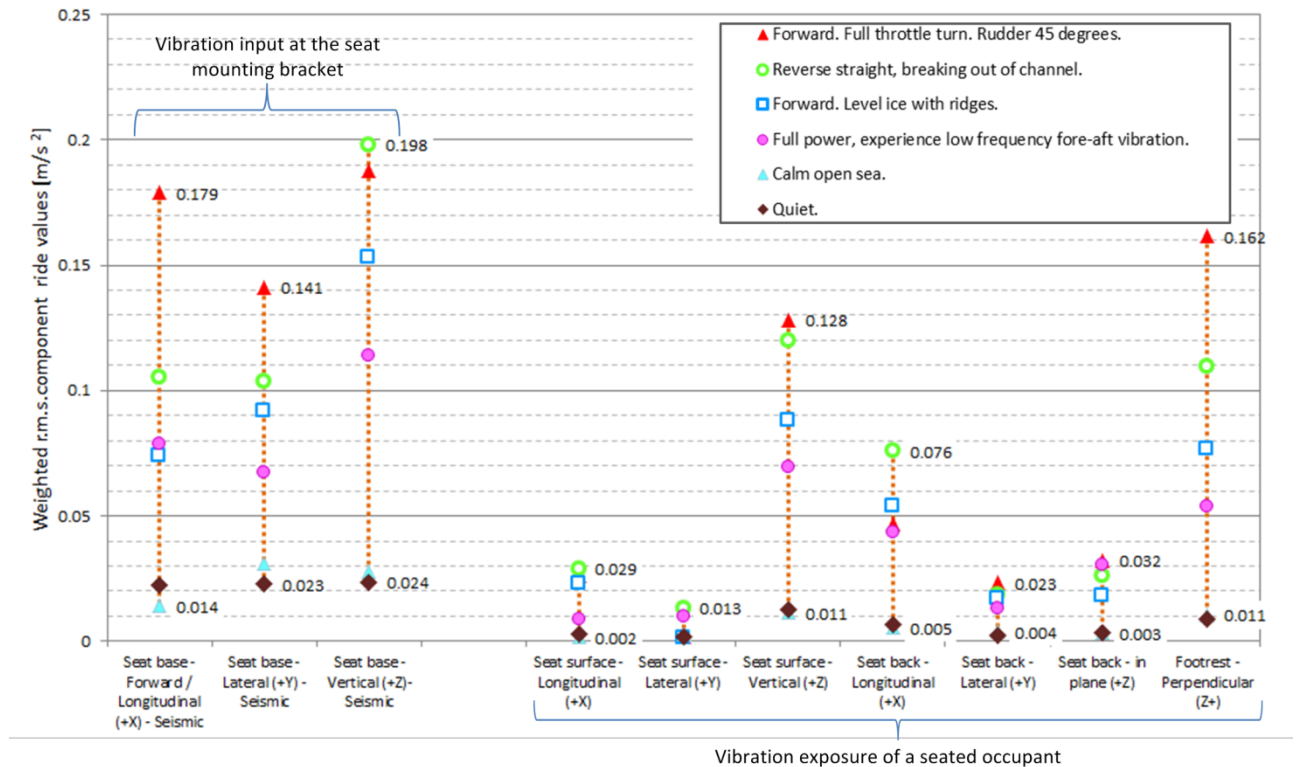
Figure 10. The magnitudes of the vibration input and the weighted component ride values for a seated occupant on the bridge of the vessel.

Table 4 lists the translational vibration input at the base of the seat (a_{Base}) and resulting overall ride values ($a_{Comfort}$) for different ship manoeuvres. Figure 10 reports the magnitudes of the vibration input and the weighted whole-body vibration comfort component ride values for a seated occupant. Results show that vibration was prominent in the translational degrees of freedom during ship manoeuvres such as conducting a port-side turn in level ice at full throttle, reversing in a freshly broken channel with the rudder at an angle and cruising forward through level ice with ridges. During ice breaking, the maximum combined axis translational acceleration input on the floor of the captain's seat was found to be 0.4 ms^{-2} r.m.s. This corresponded with a maximum overall ride value for a seated subject of 0.15 ms^{-2} r.m.s. during a forward full-throttle turn in a level ice field. By comparison, the vibration experienced during this full-throttle turn in a level ice field is ten-fold that of the vibration exposure when compared to calm seas or quiet conditions. At the seat base, vertical vibration was more dominant than fore-aft and lateral vibration during ice-breaking manoeuvres. The Cleeman Dolphin seat transfers most vibration to a seated occupant vertically through both the seat surface and the footrest and longitudinally through the seat back. In subjective terms vibration levels are likely to be experienced as "barely noticeable" to "not uncomfortable" for all measurements obtained during the ice trail (ISO 2631-1:1997/Amd 1:2010)..
