Identification of Hazards during Search and Rescue Operations in Cold Climate

KEY WORDS: Arctic, cold climate, hazard identification, Polar Code, search and rescue

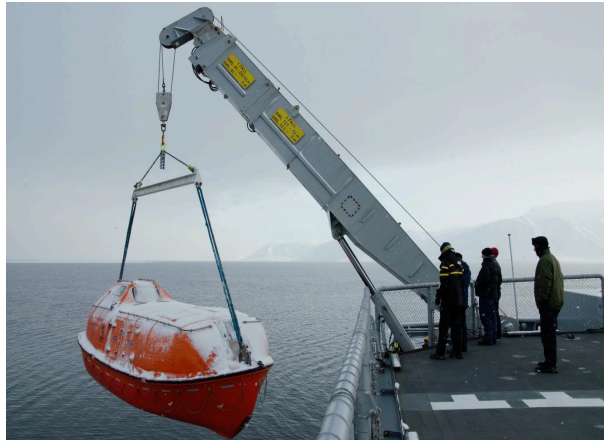
Figure 2. Lifeboat being lowered into the water with the deck crane. Photo © Jan Erik Jensen

As a part of the preparations for the exercise, the lifeboat was launched from the deck of KV Svalbard using the deck crane (Figure 2). In addition, transport between KV Svalbard and the survival crafts was carried out using the two MOBs (Man Overboard Boats), and these were also utilized for toilet breaks. Moreover, there were at least one MOB boat stationed close to the survival crafts during the exercise for safety reasons. The exercise was started Sunday 24th of April, at approximately 09:40, when all participants had been transported to the lifeboat/ life raft with the MOBs. The weather during the exercise was ideal for performing the exercise, with an ambient air temperature of about -9°C , a water temperature of about -1°C and little wind. These are considered representative weather conditions for the cruise ship season in Svalbard. Due to the favorable weather conditions, seasickness was not an issue for any of the participants.

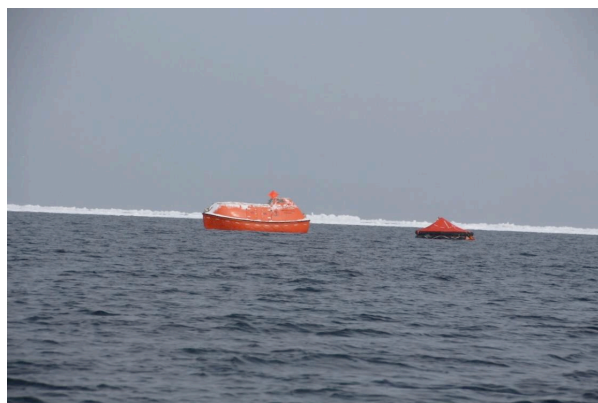
Figure 3. The lifeboat and the raft © Trond Spande

The lifeboat and life raft employed for the exercise as well as PPEs, which the participants wore during the exercise are depicted in Figures 3 to 6. In phase 1, each participant wore standard SOLAS approved PPEs, ranging from life jackets to insulated survival suits. The goal was to see how long the participants would stay in the lifeboat before they experience the cold stress – the response of the body to cold temperatures resulting from heat loss. The heat loss can be due to whole-body cooling and/or local cooling, including extremity cooling, convective skin cooling, conductive skin cooling (contact cooling), and cooling of respiratory tract.

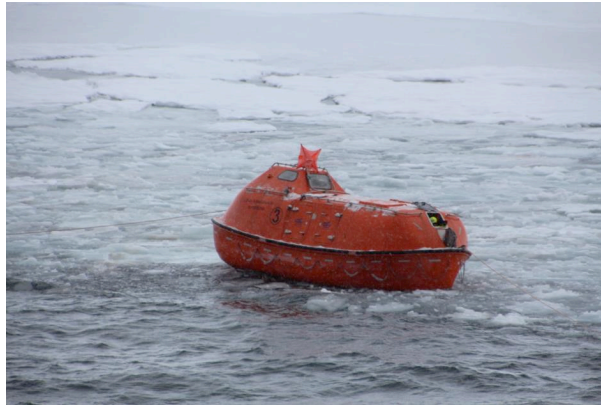
Figure 4. Lifeboat drifted into a belt of ice during the exercise © Trond Spande

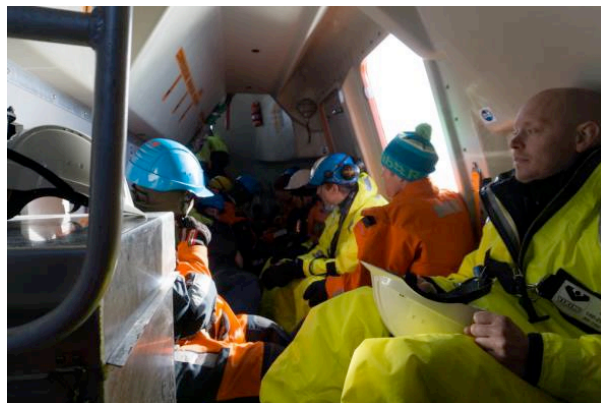
Figure 5. Situation inside the lifeboat © Bjarte Odin Kvamme

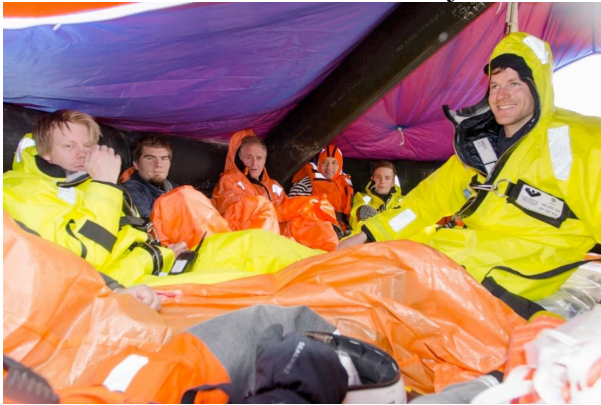
Figure 6. Situation inside the raft. People with survival suits are warm, and had to open their suit to avoid sweating. © Jan Erik Jensen
