## **Laser scanning as a tool for monitoring road deformations in Svalbard**

Fedor D. Iurov<sup>1</sup>, Nataliya A. Marchenko<sup>2</sup>

<sup>1</sup> Lomonosov Moscow State University, Moscow, Russia

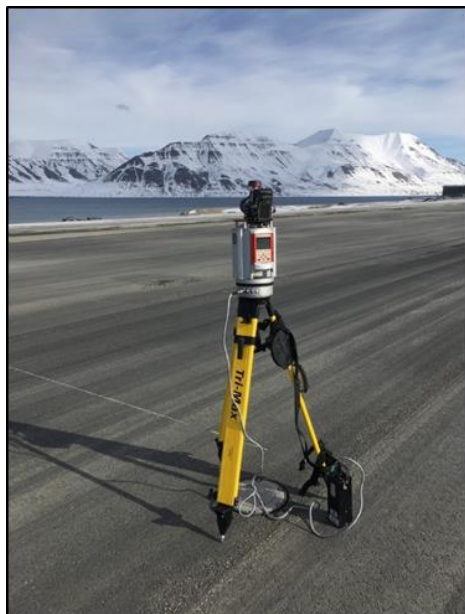
We used a RIEGL VZ-1000 laser scanner (Fig. 1) to examine linear infrastructure in Longyearbyen. This device has a high measurement accuracy (5-8 mm) and allows for 3D point clouds to be obtained at a distance of 800 m or more. The average time required to survey from one point is from 5 to 15 minutes depending on the selected scanning parameters. Scanning an object returns a “cloud” of millions of points, oriented in space relative to each other, which greatly improves the precision of measurements. The scan result is a 3D terrain model oriented in space.

Fig. 1. Laser scanner RIEGL VZ-1000

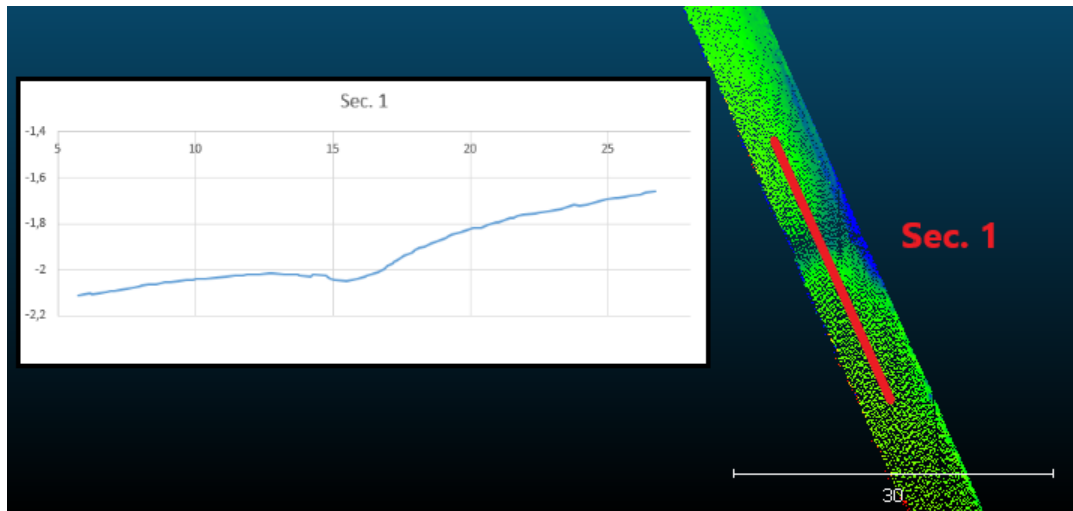
Fig. 5. Longitudinal profile of the road surface in the area of pavement subsidence

Coloring by height only identifies large (several meters) irregularities on the surface of the surveyed object. For the analysis of smaller irregularities and deformations, this method is not suitable. The most obvious method for studying surface micro-relief is the construction of height profiles. The point distribution gives an overview of the general relief of the scanned object, but also allows for irregularities to be identified on the centimeter scale. Both CloudCompare and RiscanPro provide this operation. Three transverse profiles of the road in area 1, created in CloudCompare, are presented in Fig. 4. The high density of points makes the profiles built with scan data informative and representative of the detailed road surface relief. In CloudCompare, it is possible to create profiles of arbitrarily defined lines, so the most “interesting” sections can be studied in detail. For example, a longitudinal profile was created for a pavement section (25 m long) where road subsidence was detected when comparing different scans. The location and magnitude of subsidence is perfectly visible on the constructed profile (Fig. 5).

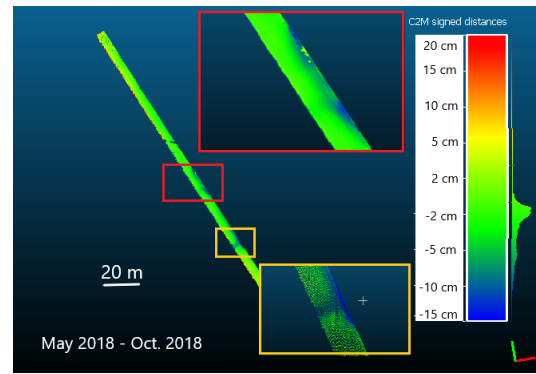
Fig. 7. Comparison of area 1 road surface elevation between the scans from May and October 2018.

Comparison of the scans from May 2018 and October 2018 showed a significantly greater number of roadway deformations. The previously identified subsidence area increased in depth by another 6-7 cm and widened along the right side of the road. In addition, a new area of subsidence was identified in a stretch of pavement along the right side of the road. The greatest subsidence occurred along the road's edge, where change in surface height reached -10 to -15 cm (this was observed in two distinct patches). There was less subsidence closer to the center of the road; on average, subsidence ranged from -5 to -7 cm (Fig. 7). Greater changes in the height of the road surface between May and October 2018 can be explained by active layer thaw during the summer and ground ice melting.

The identified deformations on the roads of Longyearbyen can be explained by changes in geocryological conditions and cryogenic processes activated by climate warming and anthropogenic activity. Temperature increase in frozen soils leads to a decrease in strength and load-bearing capacity and an increase in active layer thickness (NCCS, 2018). Increase in active layer thickness increases frost heaving processes in the winter and subsidence during the thawing period. These processes are not evenly spatially distributed. The magnitude of subsidence and heaving depends on soil moisture, which varies under the road surface. Another reason for road deformation in Longyearbyen is man-made flooding along road embankments. Under the roads, a frozen core is formed (due to more intense freezing in winter caused by the clearing of snow from the roads), which prevents runoff and infiltration of surface and groundwater. Poor construction design and culvert failure can lead to flooding along road embankments; this phenomenon is common in Longyearbyen (Fig. 9). The warming effect of ponds further weakens frozen soils, increases active layer depth, and can lead to thermokarst development. As a result, road subsidence is greatest along the road shoulders, as seen in Figure 7.

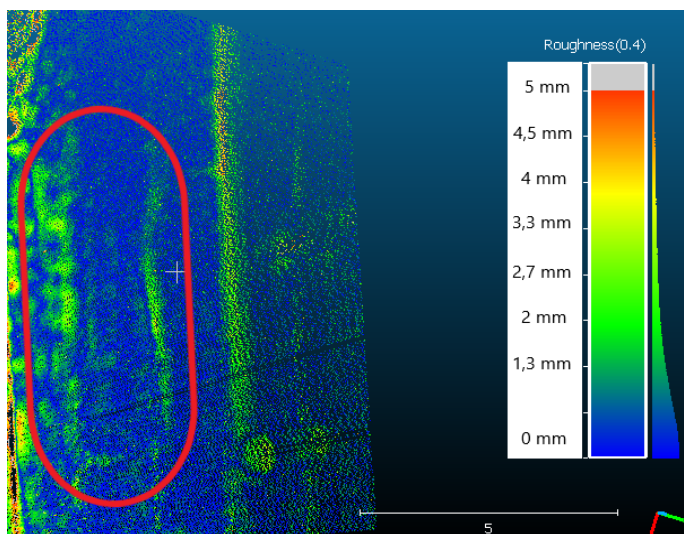
Fig. 8. Road segment with ruts 3-4 mm deep, visualized by calculating surface roughness.

Another method for detecting deformations is to determine the mathematical roughness of the surface. For each of the points obtained via scanning, a “roughness indicator” is calculated, which represents deviations from the plane in which most of the surrounding points lie. The radius in which the deviation is estimated is set by the user, allowing for analysis of surface deformations at various scales. With a smaller radius, smaller deformations will be noticeable. For example, with a radius of 0.5 m, very insignificant deformations and irregularities are visible, such as ruts on roads (seen in area 2) with a depth of less than 2 mm (Fig. 8). The main

disadvantage of this method is that the roughness indicator only has positive values. Thus, both surface subsidence and buckling (i.e. downward and upward displacement) are indicated in the same way as a deviation from the average surface. To determine the vector of irregularities, manual processing and interpretation is required.

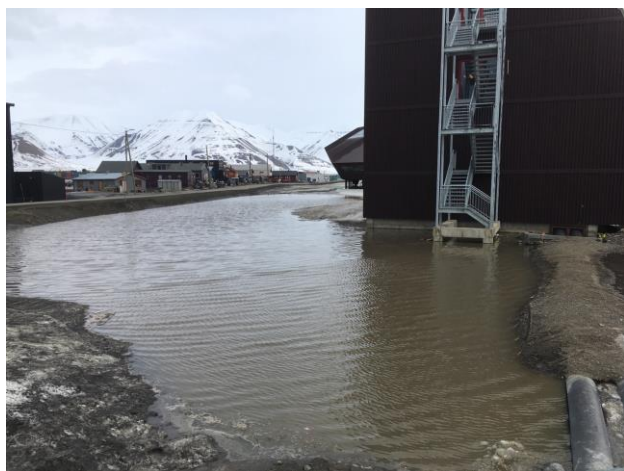
Fig. 9. Flooding along the road in Longyearbyen
