PORT AND OCEAN ENGINEERING UNDER ARCTIC CONDITIONS
TECHNICAL UNIVERSITY OF NORWAY

SUBAQUEOUS SLOPE FAILURES IN
NORWEGIAN FJORDS

Laurits Bjerrum, Dr.sc. Norwegian Geotechnical
Institute Oslo, Norway

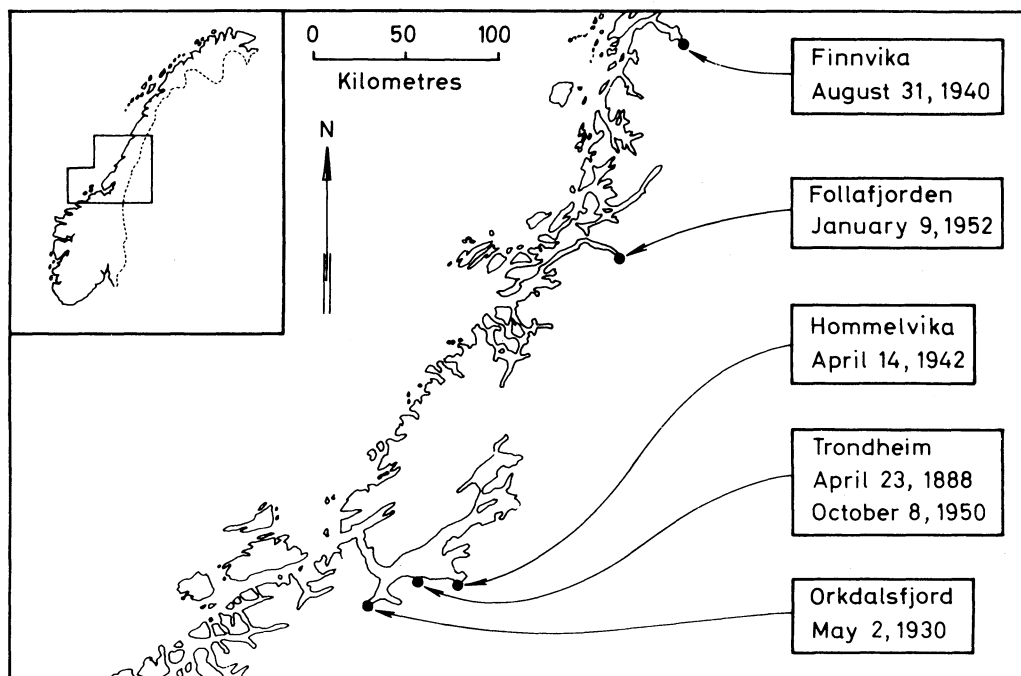
PHOTO 4 The slide in Hommelvika 1942

In the period up to the slide rock fill was being placed in order to reclaim an area in the harbour of Hommelvika for a military slipway for hydroplanes. Two days before the slide the outermost part of the fill slid out but the filling was resumed and continued until the main slide occurred, see Fig. 4.

The slide took place at 7:45 p.m. on April 14, 1942. This was 40 minutes after spring low water tide. The slide started by the disappearance of the area recently filled-in. It propagated quickly in a southern direction, see Fig. 4, and caused first the failure of another recently reclaimed area next to the Halstad river and then the failure of the outermost part of the deep water harbour recently completed by the Norwegian State Railways. Finally, the older part of the deep water harbour slid out.
