SECOND INTERNATIONAL CONFERENCE ON
PORT AND OCEAN ENGINEERING UNDER ARCTIC CONDITIONS
UNIVERSITY OF ICELAND
DEPARTMENT OF ENGINEERING AND SCIENCE

CORROSION OF MARINE STRUCTURES AT
GODTHAAB, GREENLAND.

E. Hulgaard &
Torben Sørensen
Civil Engineers,
Partners

Hostrup-Schultz
& Sørensen
Consulting Engineers

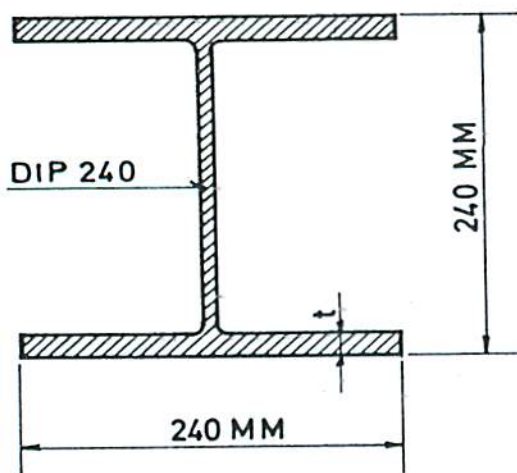
The results of these investigations are shown on figure 4.

The measurements show that the maximum corrosion occurs at a level $\div 2.0$ m to $\div 2.5$ m, which is 0.5 - 1.0 m below the mean low water level. In this zone the reduction of the flange thickness is up to 8.6 mm. For another pile the maximum reduction at level $\div 2.5$ was measured at 15 mm. Below $\div 2.5$ the corrosion is about 1-2 mm and above level $\div 1.5$ m it is only about 0.5 mm.

The corrosion did not normally occur evenly on the two sides of the flange. For the pile described above, the maximum corrosion from one side was 6.0 mm, corresponding to $\frac{6.0}{20} = 0.30$ mm/year.
